# Fatality on board the motor yacht *Calliope*

Rozelle Bay, New South Wales | 8 February 2013

**ATSB Transport Safety Report**  
Marine Occurrence Investigation  
297-MO-2013-003  
Final – 12 May 2014

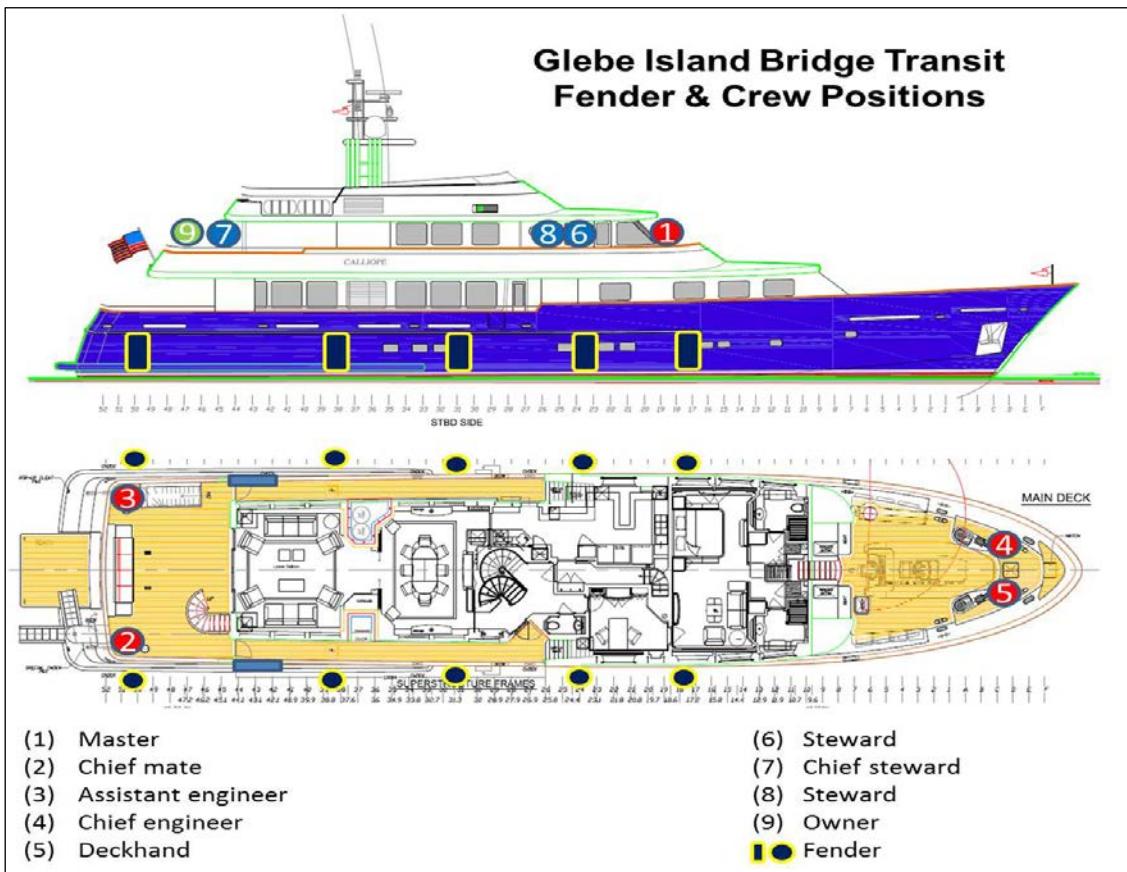
**Figure 5: Fender and crew positions for transiting the Glebe Island Bridge**

At about the same time, the chief mate told the crew to raise the fenders in preparation for passing through the Glebe Island Bridge. When this was completed, he stood down the stewards, but kept the remaining crew in position to standby the fenders (Figure 5).

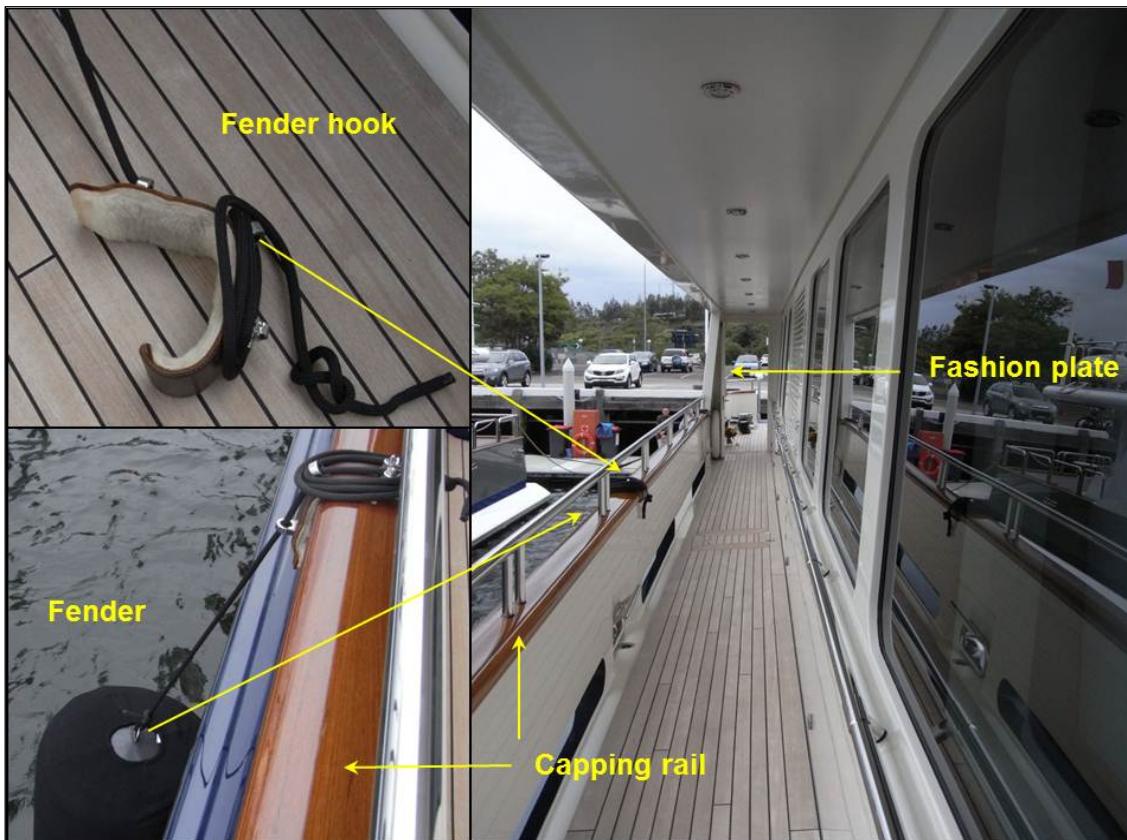
**Figure 6: Fender Hook position on capping rail**

At 1346, *Calliope*'s bow entered the opening between the bridge structures. Soon afterwards, the chief mate advised the master, by UHF radio, that he needed to move the stern to port. The chief mate thought that contact with the bridge structure was imminent so he walked forward along the starboard main deck to reach and then re-position the fender just forward of the fashion plate. He lifted the fender hook from the capping rail and released the fender so he could move it (Figure 6).

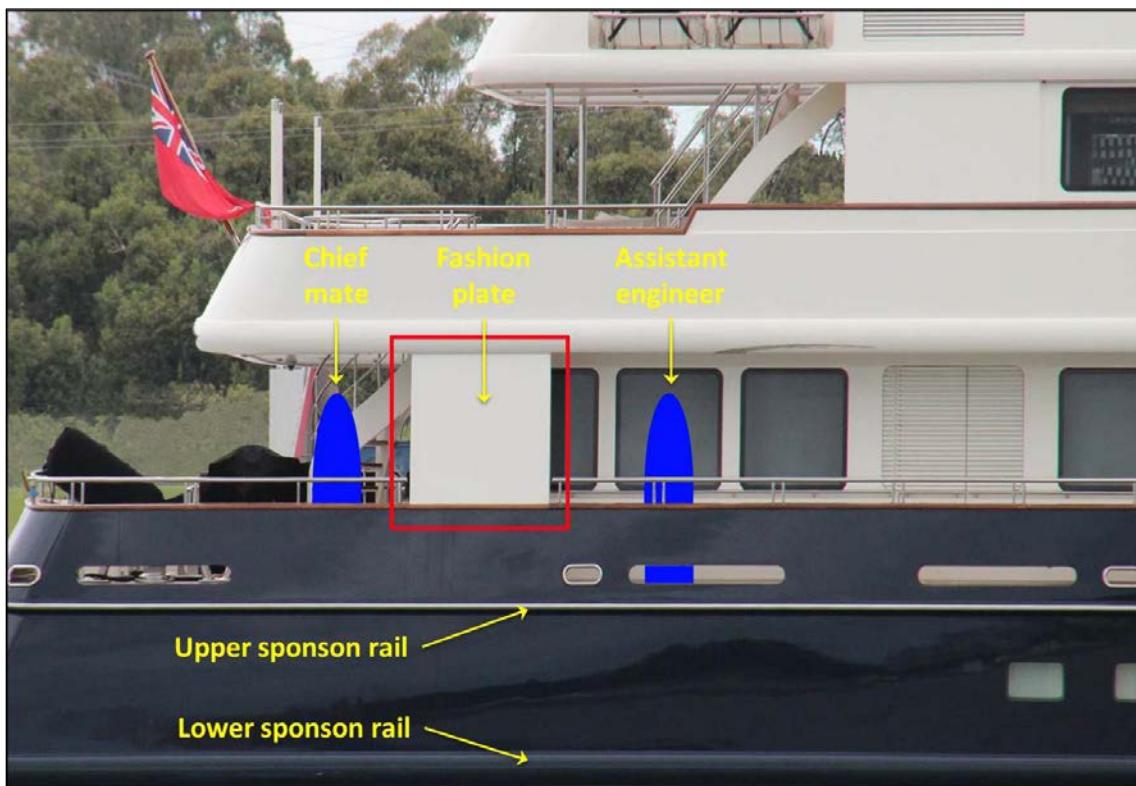
**Figure 7: Position of chief mate and assistant engineer prior to the accident**

The chief mate positioned the fender so that it was between the yacht's upper sponson rail (Figure 7) and any possible points of impact on the bridge structure. Thinking that he would need to move the fender aft, past the fashion plate, he called for help from the assistant engineer who was positioned on the port quarter. The assistant engineer moved quickly to help and took control of the fender. The chief mate then walked aft, past the fashion plate, in preparation for receiving the fender.

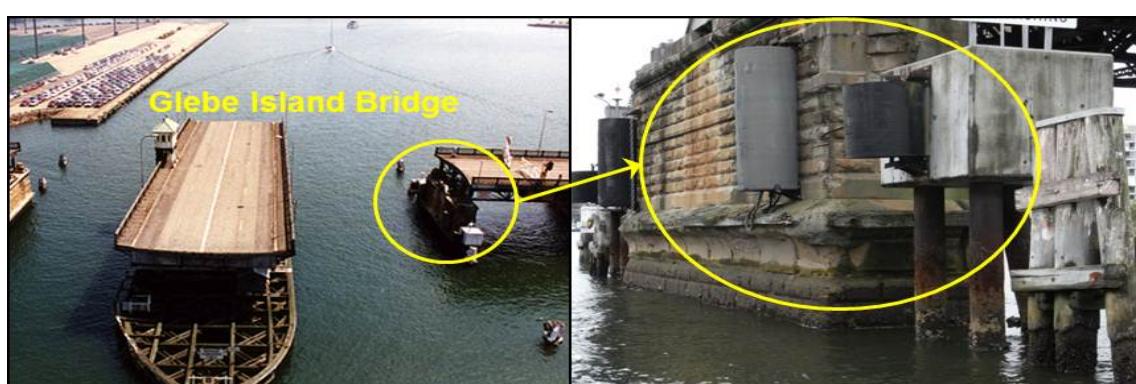
**Figure 8: Glebe Island Bridge structure and fenders**

At about 1347, the assistant engineer was caught between the yacht's fashion plate and a bridge mounted fender (Figure 8). He was pulled over the yacht's side and into the water.

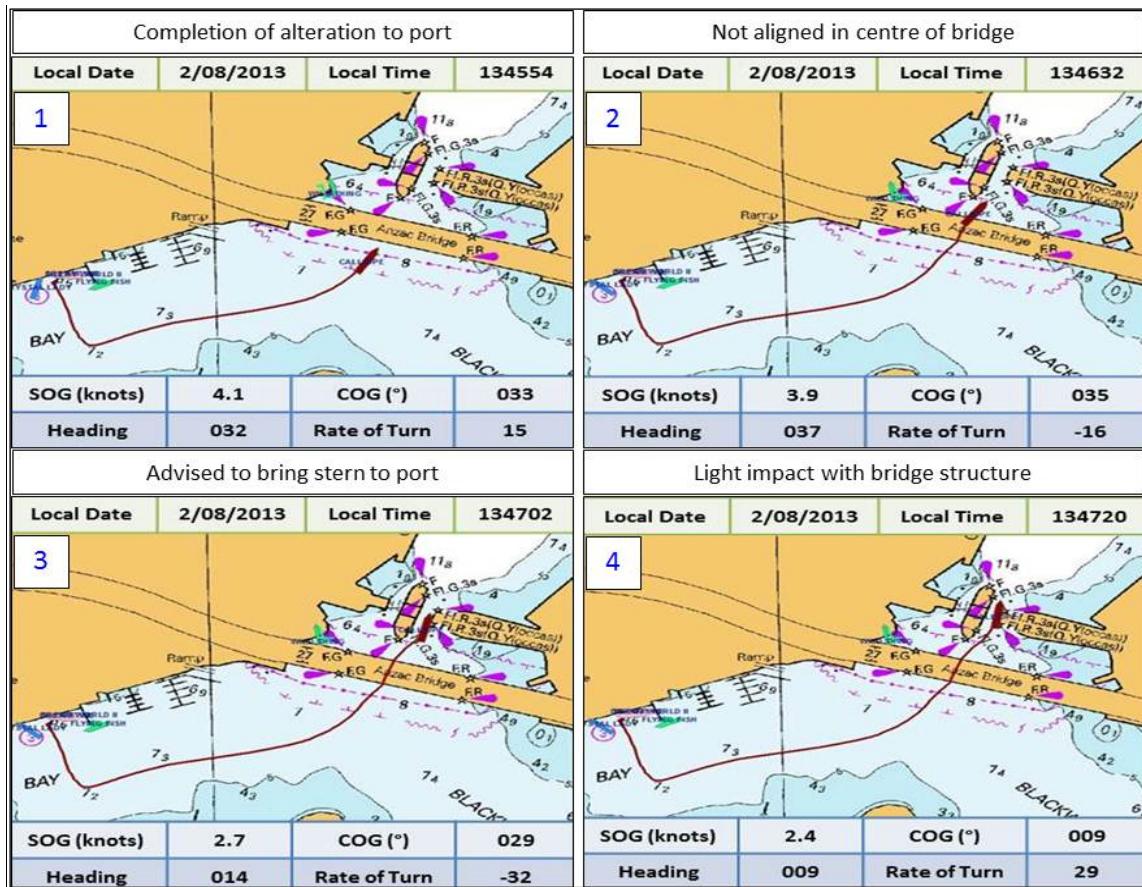
**Figure 11: Navigational information relating to Calliope's track from berth to bridge**

to starboard and the yacht's heading swung over 30°. As a result, the yacht was not on a steady course when it was transiting the bridge and veered into it (Figure 11).

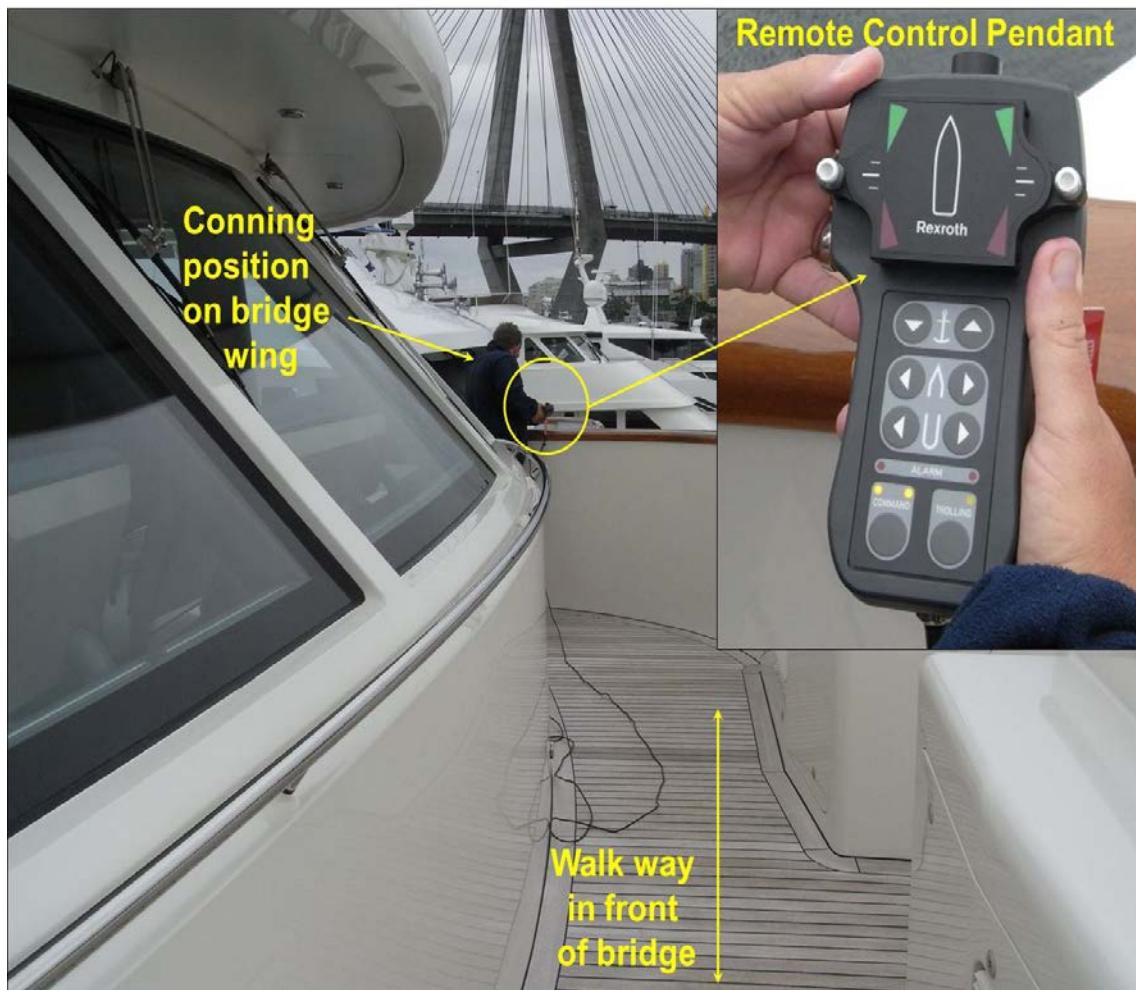
**Figure 12: Conning position during manoeuvring**

It was common practice for the master to position himself outside the bridge (Figure 12) when he manoeuvred *Calliope* at low speeds, using the bridge remote control pendant. He was then able to walk across the front of the bridge, from bridge wing to bridge wing, to observe the sides of the yacht during manoeuvring.
