REPORT

SL 2019/01

REPORT ON AIR ACCIDENT IN PORT OF BERGEN, HORDALAND COUNTY, NORWAY, 10 MAY 2017 INVOLVING AIRBUS HELICOPTERS AS 350 B3, G-HKCN

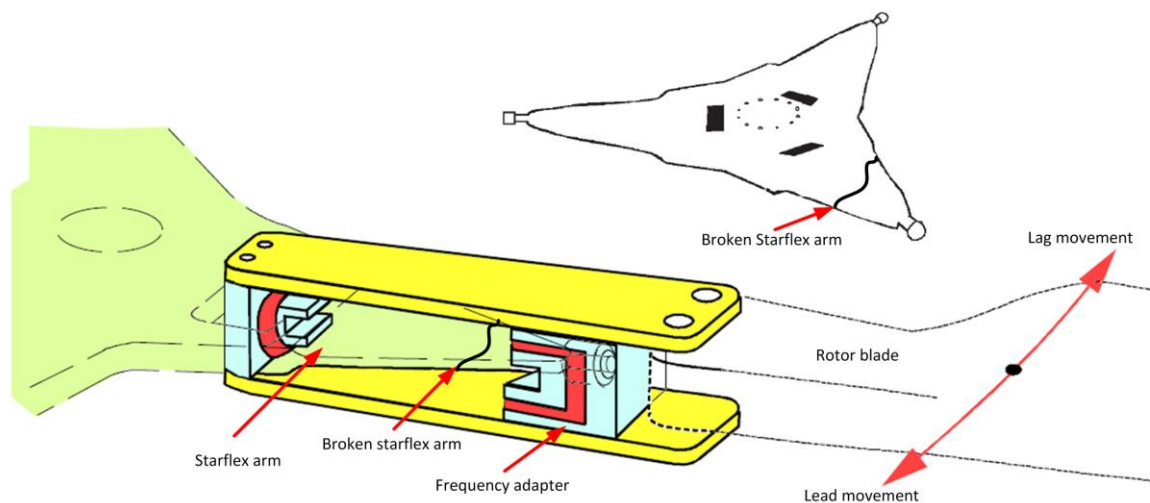
- 2.3.1 Phase 1: When the tarpaulin hit the main rotor, the rotor was damaged in such a manner that significant vibrations occurred. These vibrations could be observed on the Appareo 1000 video recording, where the imagery suddenly became blurry. Such damages are known from other accidents as a result of plastic sheets, tarpaulins or bulk cargo bags being blown through the rotor disc and thereby hitting the leading edge of a rotor blade⁷. The Starflex (main rotor composite hub) arms are vulnerable for impact shocks caused by materials hitting the attached rotor blade. In other accidents of similar nature, Starflex arms have broken off. A broken Starflex arm will allow large lead/lag movements of the blade since the frequency adapter no longer is attached to the Starflex main rotor hub. The consequence will be a major imbalance in the rotor disc and this will generate heavy vibrations. Loss of control of the helicopter is the most probable outcome of such damages to the Starflex (see Figure 10).

Figure 10: Effect of broken Starflex arm. Illustration: AIBN/Airbus Helicopters
