**Report of the investigation of
the accident resulting in one fatality and one serious injury
during the mooring of the motor yacht**

JEMASA

**in Phuket, Thailand
on 18 February 2009.**

Casualty 01/2009

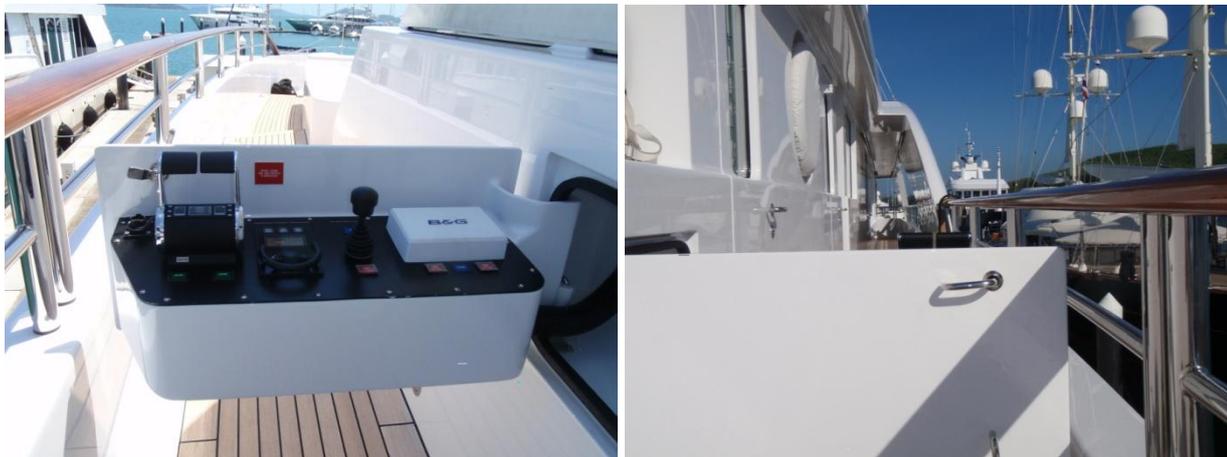
Figure 1: Open Wing Station

JEMASA has two bridge wing control stations that fold into the deckhouse when not in use. When the wing stations are deployed they extend the whole width of the walkway at bridge level and impeded fore and aft movement on their side of the yacht. (See figure 1)

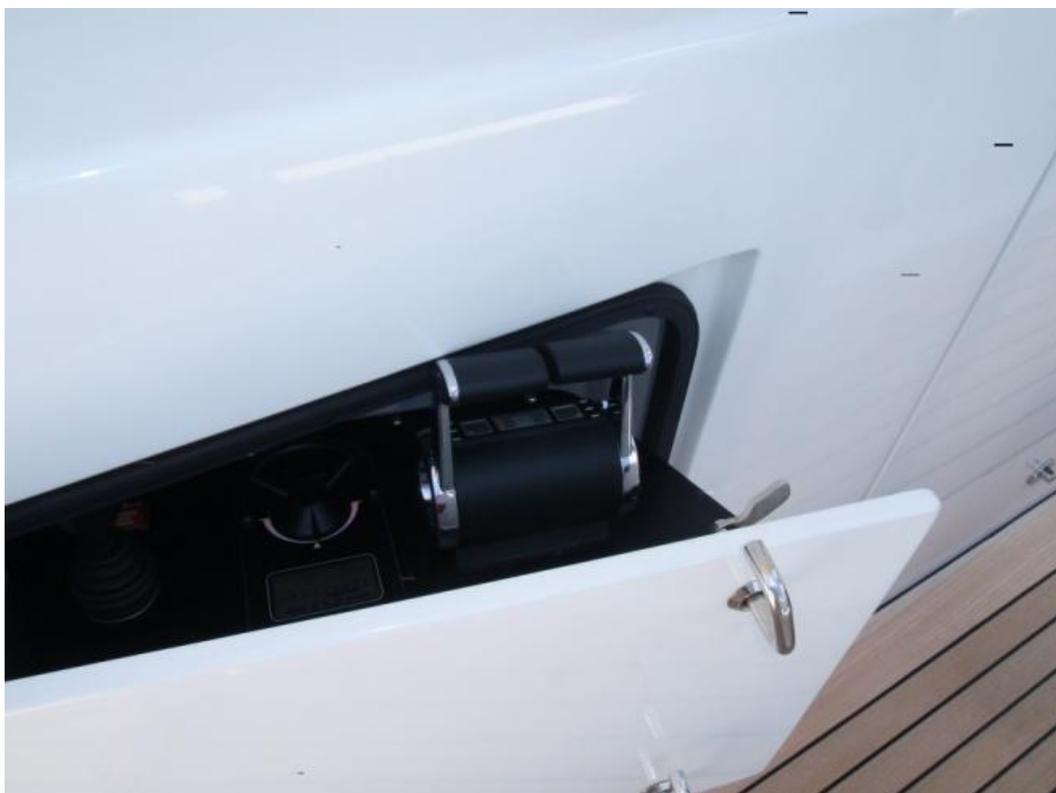
Figure 2: Engine Control Height

When the deckhand came to the still open port bridge wing station, he put the engine controls in the full ahead position and closed the wing station. It is necessary to place the engine controls in this position because, when in use, they stand higher than wing control opening in the deck house when placed in the “neutral” position. (Figure 2)

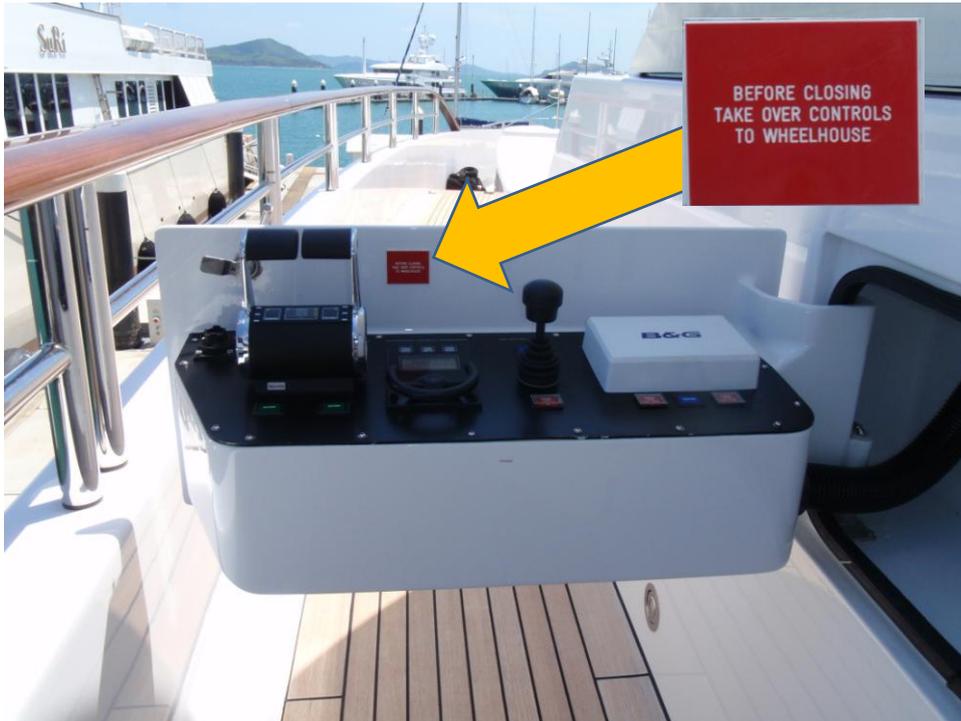
Figure 3 View of plastic warning sign

On JEMASA the hazards associated with unintentionally engaging the engines was recognised and a plastic sign was fitted at the control station which read “BEFORE CLOSING TAKE OVER CONTROLS TO WHEELHOUSE” (figure 3).

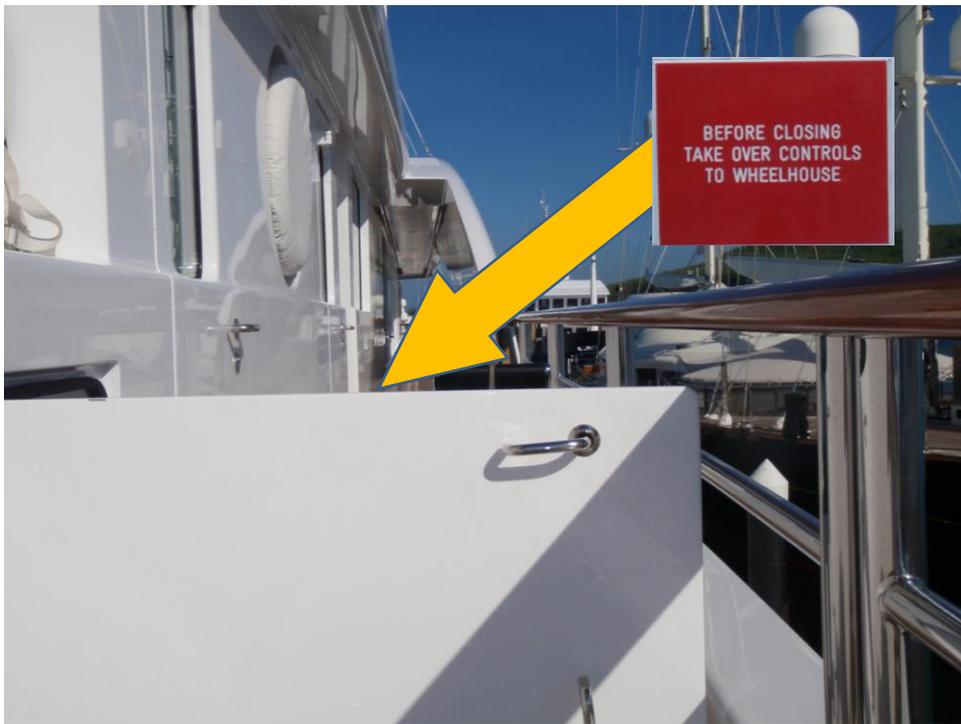
This sign would not have been visible to the deckhand as he made his way aft from the foredeck (figure 4). In addition, the duties of the deckhand did not call for him to be familiar with the control station layout and he was not required to operate any of the controls.

Figure 4: Deckhand's view of console with warning sign obscured

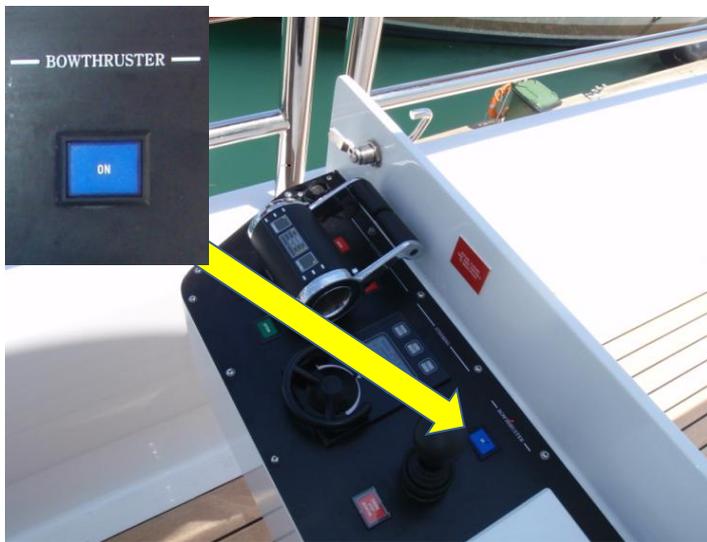
The deckhand stated that he checked that the “blue light” (figure 5) was out before closing the control station, believing that when illuminated this light indicated when the control station was “live” and in control of the vessel. The “blue light” refers to the bow thruster control only. Engine control is indicated by the yellow light shown in Figure 6. This light is small and its status is difficult to determine in bright daylight.

Figure 5: "Blue Light" believed by deckhand to indicate console status

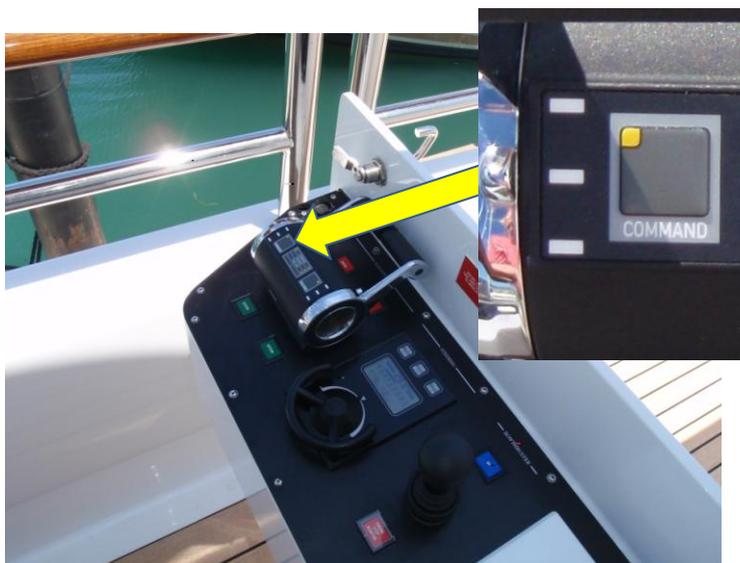
Figure 6: "Yellow Light" indicating Engine Control

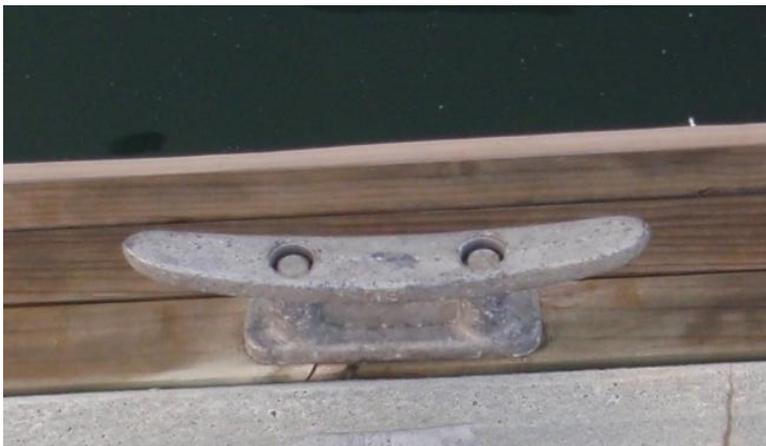
Figure 7: Cast Mooring Cleat

1. Cast aluminium cleats attached to the dock by bolts through the timber wales, as shown in figure 7;

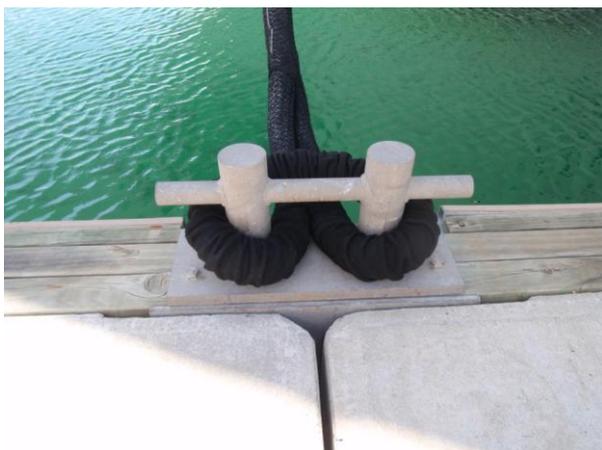
Figure 8: Fabricated Mooring Bollards

2. Fabricated steel bollards bolted through the timber wales and into the concrete pontoons, as shown in figure 8; and

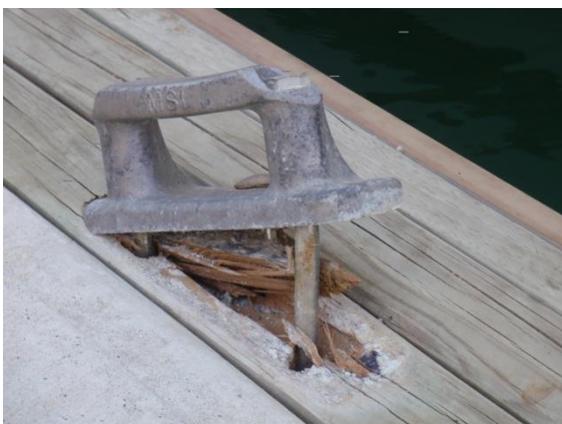
The cleat holding the stern line failed (Figure 10). When the cleat failed the mooring rope recoiled and part of the cleat was sent inboard where it struck the superstructure. This cleat had insufficient strength to withstand the abnormal mooring loads caused when the engines on JEMASA engaged ahead.

Figure 10: Failed Stern Cleat

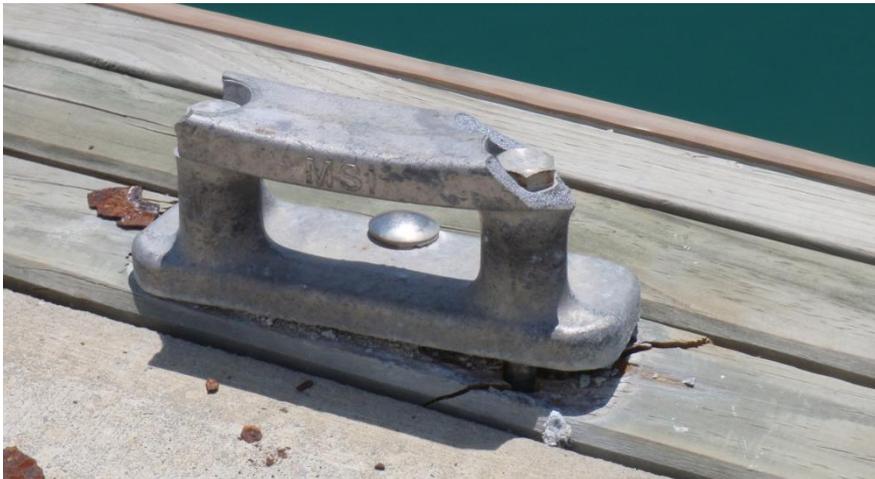
The cleat holding the head line failed (figure 11), causing the mooring rope to recoil. This cleat also had insufficient strength to withstand the abnormal mooring loads caused when the engines on JEMASA engaged ahead.

Figure 11: Failed headline cleat

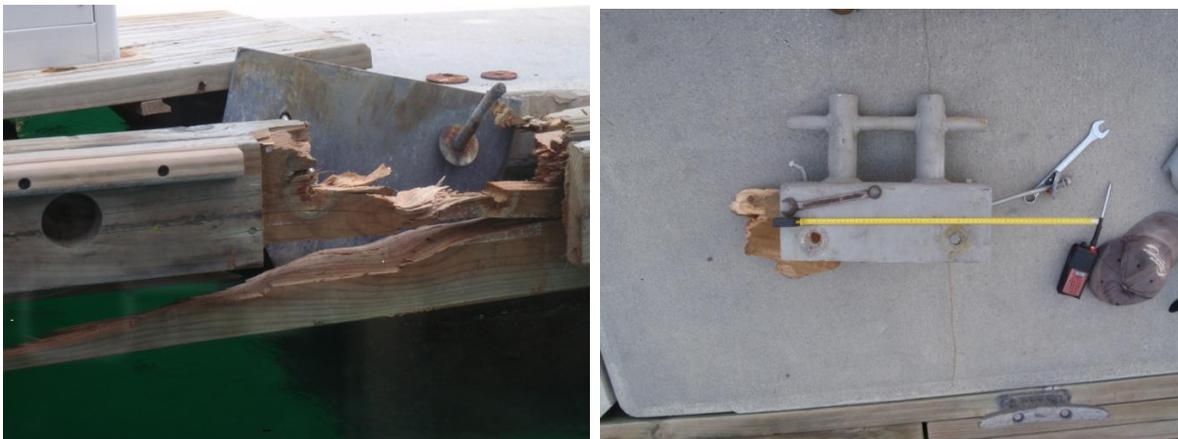
The mounting of the bollard holding the forward back spring failed and the entire bollard arrangement became detached from the quay (figure 12). When the mooring rope recoiled, it brought with it the bollard which was still attached and sent wood debris flying up the quay. It is believed that it is this debris and recoiling mooring rope which struck the two victims.

Figure 12: Bollard pulled from quay

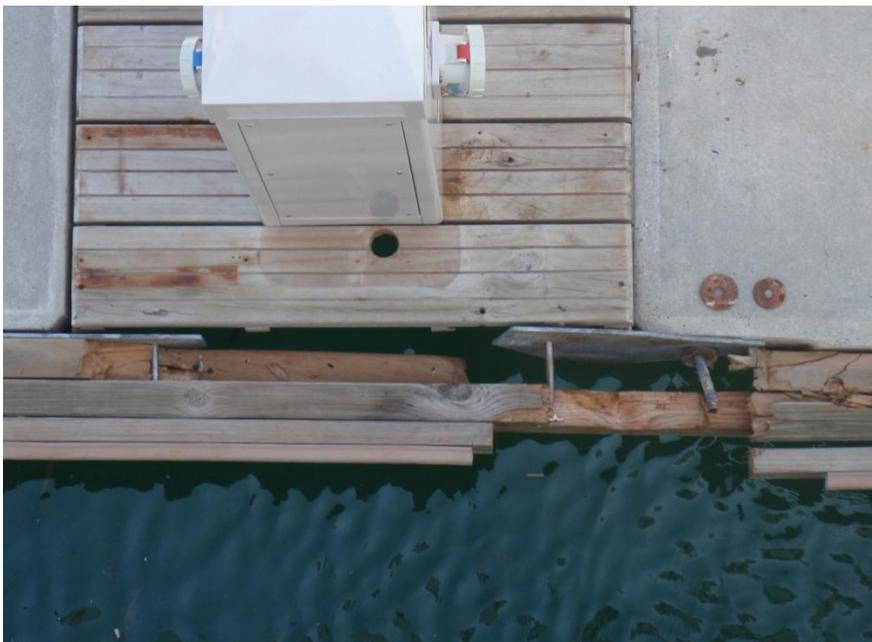
The failure mode of the bollards differed from the failure of the cleats in that the bollard themselves had sufficient strength to cope with the loads, but its attachment to the quay did not. Normally these bollards are mounted between two adjacent concrete pontoons and are held in place by two rods running through the entire thickness of the pontoons. The bollard that failed was mounted between one pontoon block and one of the spaces between pontoons for the steel piles and utility

stations. This bollard was held in place by a single rod running through the pontoon block and a bolt connected to a backing plate behind the soft wood wales.

When the load on this bollard was increased and the soft wood wales failed, it placed a torque reaction centred on the single through pontoon rod. In turn, this rod failed and the bollard was freed from the quay.

Figure 14: Failed bollard mounting through one concrete pontoon and one backing plate.

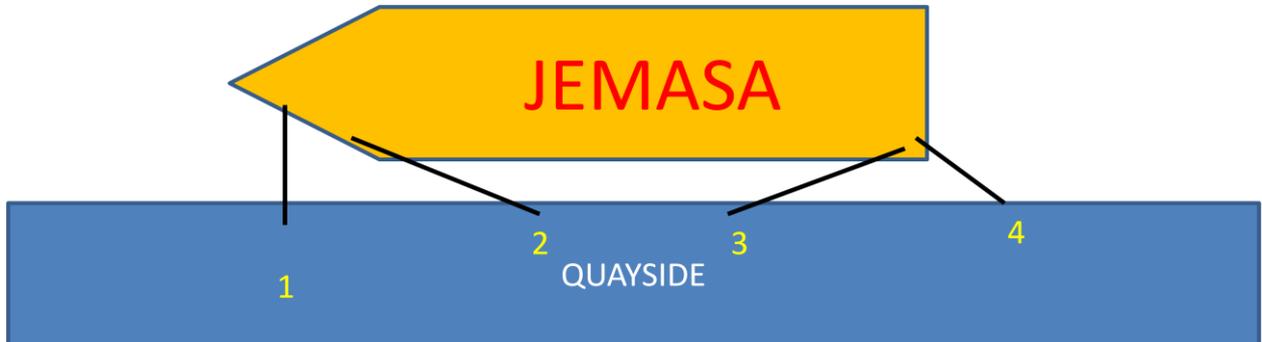
At the time of the accident, JEMASA had four mooring lines secured to the quay as represented in the above diagram. When JEMASA moved ahead, lines 1, 2 and 4 pulled from the quay. All mooring ropes were Nylon Double Braid ropes of 56mm nominal diameter and with a minimum tensile strength of 805.1 kN.

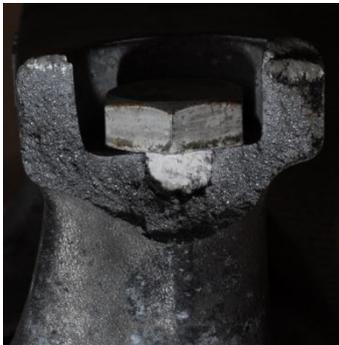
Figure 18: Typical Cleat Fracture
