Report on the investigation of
a fall from height on the bulk carrier

Equinox Seas

resulting in one fatality

REPORT NO 12/2024

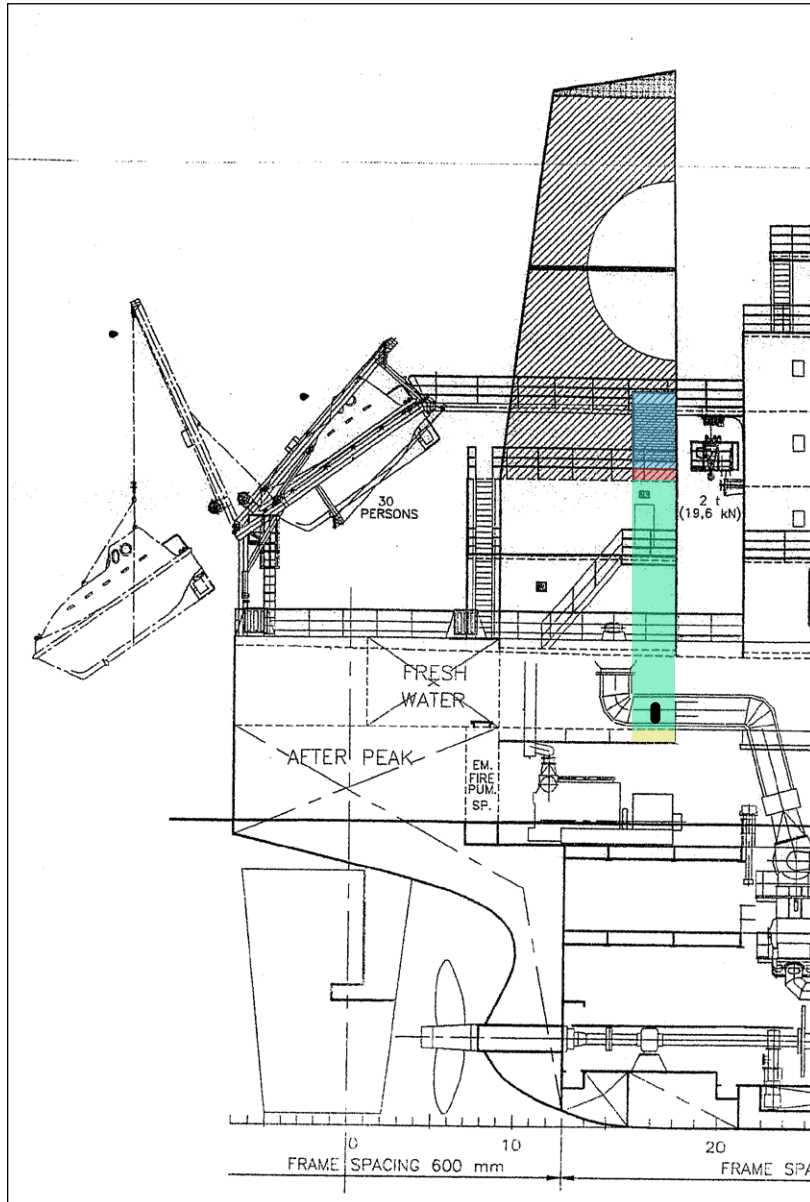
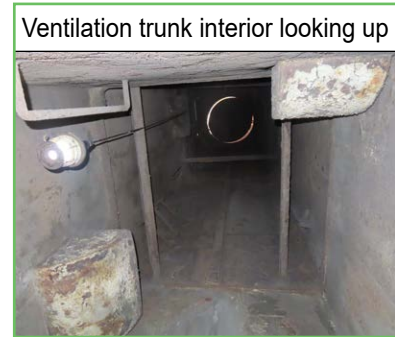
Figure 3: Starboard engine room ventilation duct arrangement

The starboard fan pedestal sat at the top of a trunk leading vertically down to the engine room. The trunk was 10m long and was of rectangular cross-section, 1.67m wide and 1.60m deep (**Figure 3**).

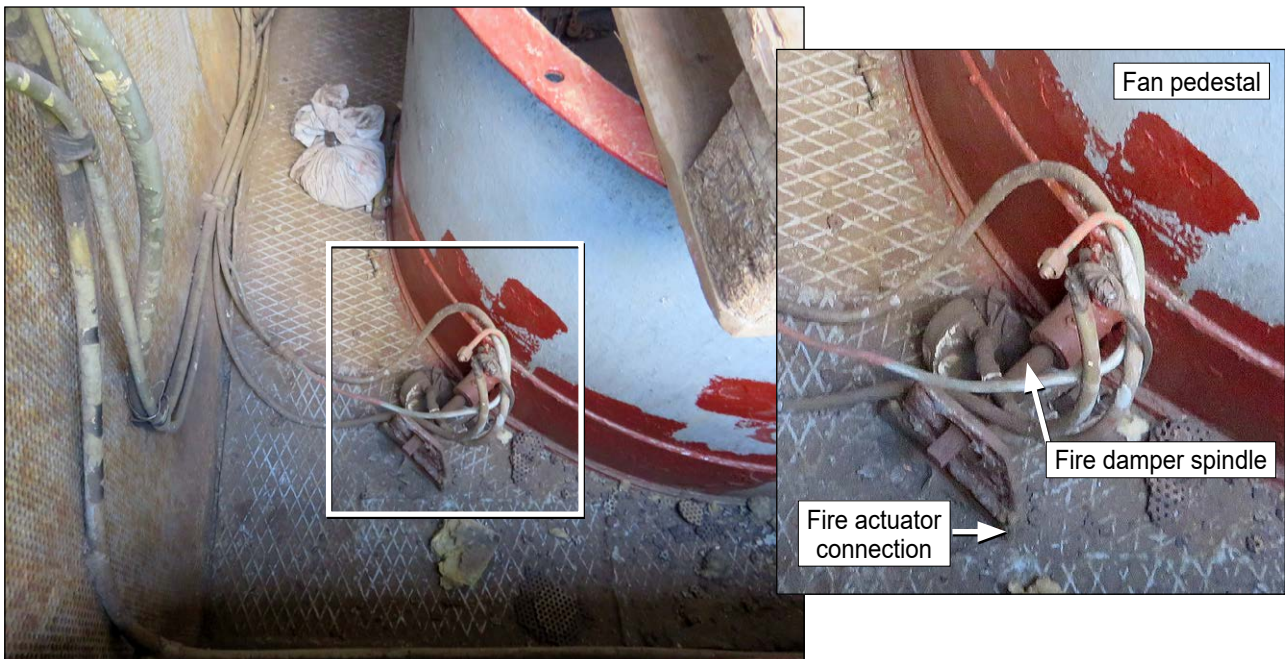
Figure 6: Disconnected fire damper actuator

After the removal of the starboard engine room fan, the fire damper actuator at the base of the pedestal was disconnected (**Figure 6**) by *Equinox Seas*' electrician. With the actuator removed, the damper was free to rotate.

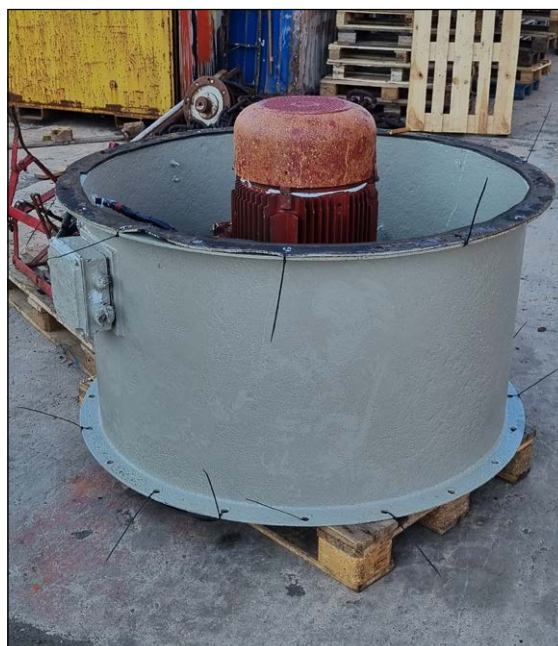
Figure 8: Starboard engine room fan unit awaiting replacement on board

The starboard fan overhaul (**Figure 8**) was completed before the shipyard ceased work for the public holiday and its reinstatement was planned for 18 April 2023.

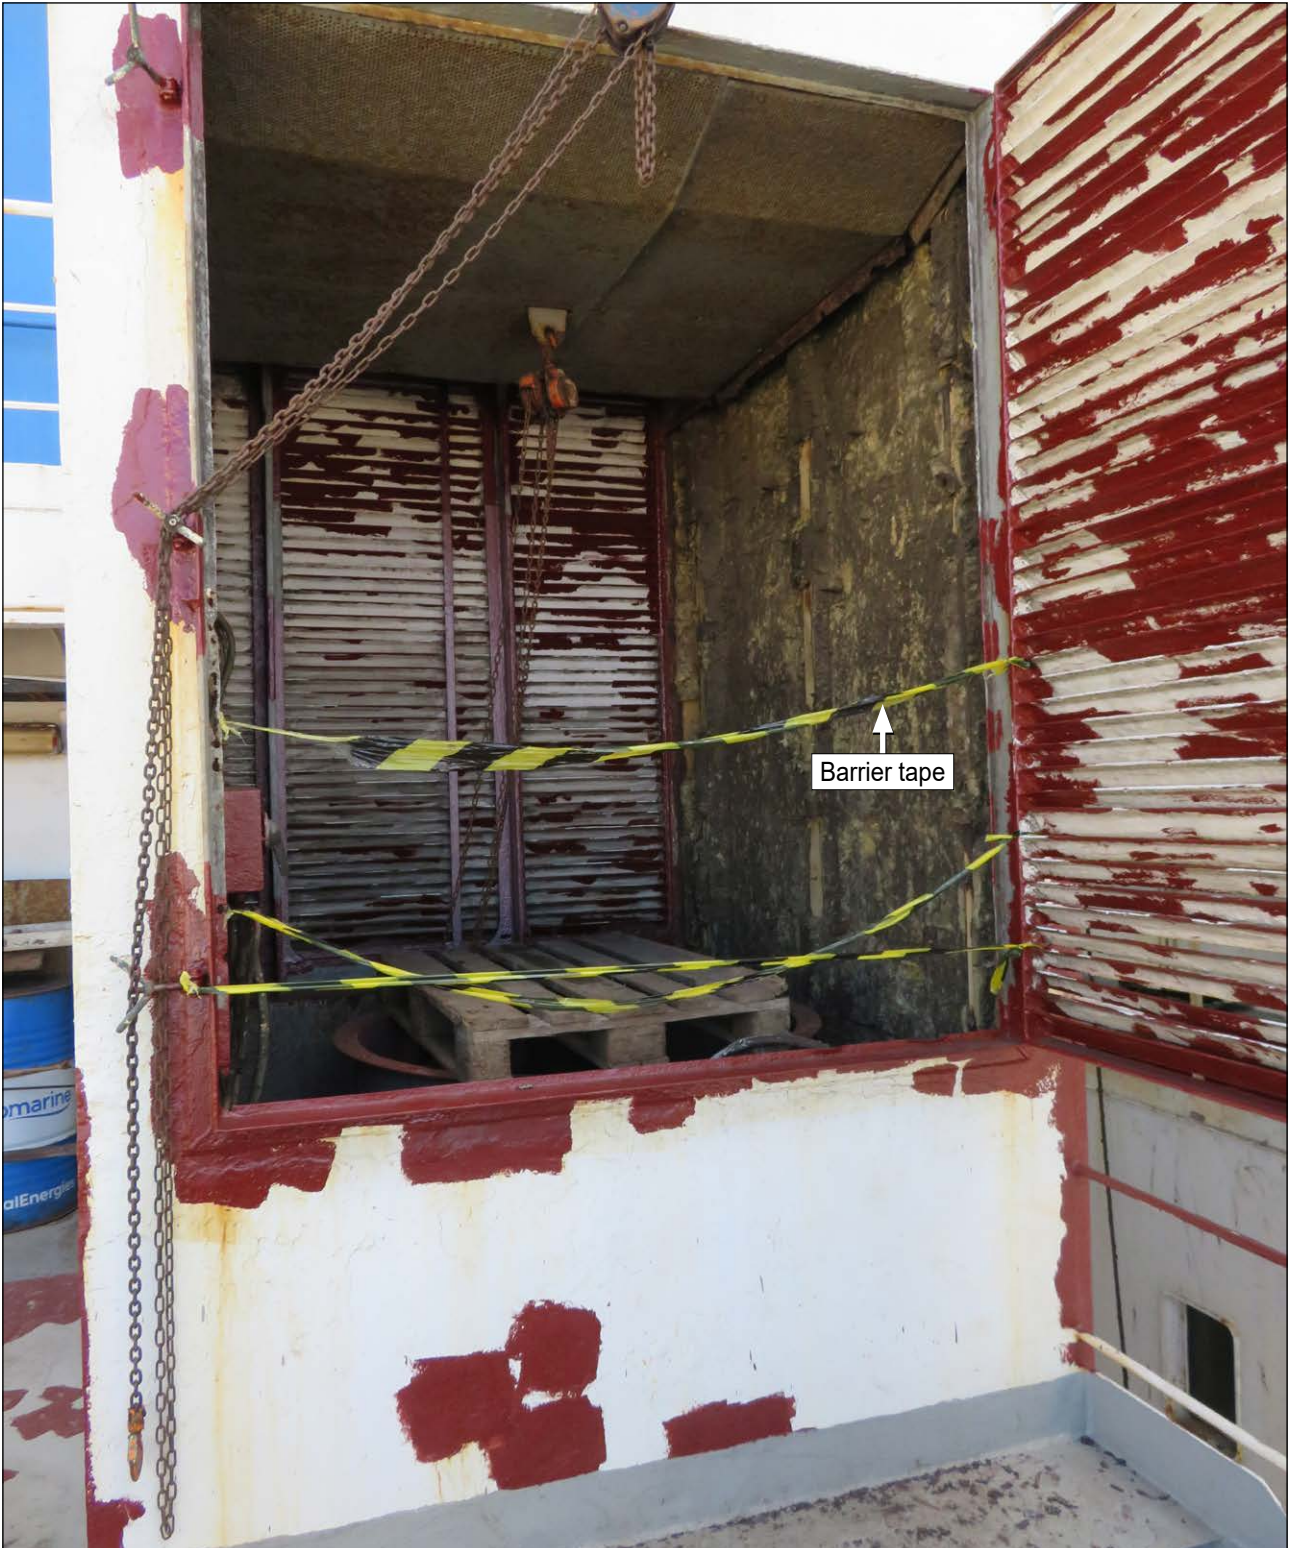
Figure 9: Barrier tape across the fan room access

Once the starboard fan was removed, the shipyard placed black and yellow striped tape across the entrance to the fan room to restrict access to the space (**Figure 9**). No steps or staging were provided outside the fan room to provide a means of access. There was no additional signage applied to indicate the nature of any hazards in the space.

The purpose of a barrier is to separate a person from a hazard. The shipyard workers had placed the black and yellow tape across the access to the starboard engine room fan room with the expectation that it would deter access. The use of such tape to warn of a hazard followed the EU directive requirements and national law; however, it did not specify the nature of the hazard it was indicating. By reference to MGN 556 (M+F), the COSWP identified that the use of black and yellow markings could be interpreted as warning of a dangerous location but did not necessarily identify the presence of a fall or electrical hazard. It is possible that the fitter might have taken the tape as denoting only the presence of the wet paint evident in the space.

Without additional signage to indicate the nature of the hazards present in the fan room, the tape alone was insufficient as a control to prevent the space being accessed.

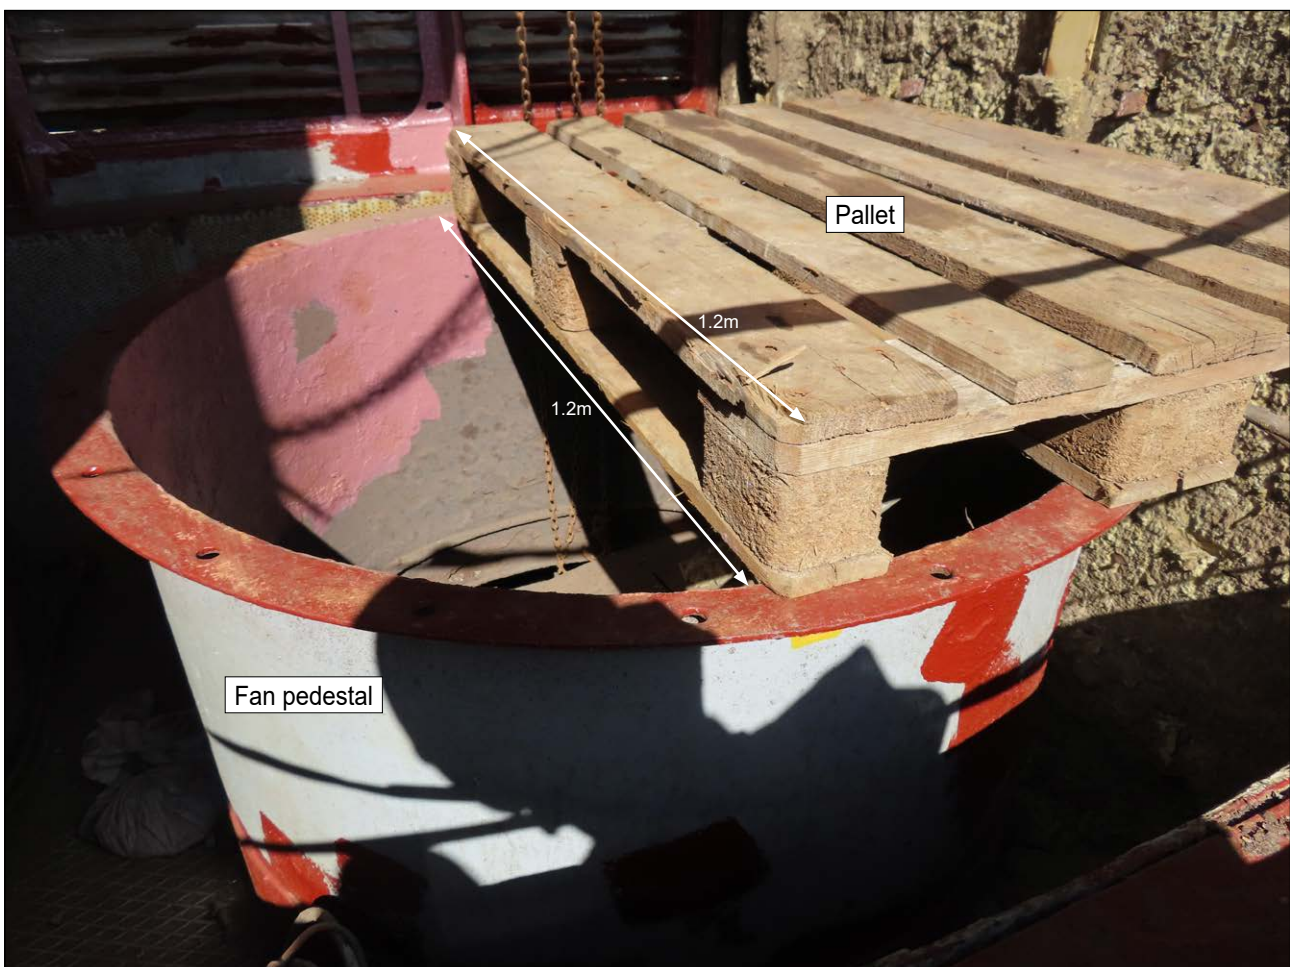
Figure 10: Pallet on the fan pedestal in the position it was reported to have been found

A standard wooden pallet⁵ was placed on the top of the pedestal, partially covering the opening. The pallet was not secured and was reported to have been positioned across the forward half of the pedestal opening (**Figure 10**). The length of the pallet was 1.2m, the same as the internal diameter of the pedestal opening.
