CAYMAN ISLANDS SHIPPING REGISTRY

FLYER TO THE LARGE YACHT INDUSTRY

Accident in Passenger Lift Resulting In Serious Injuries

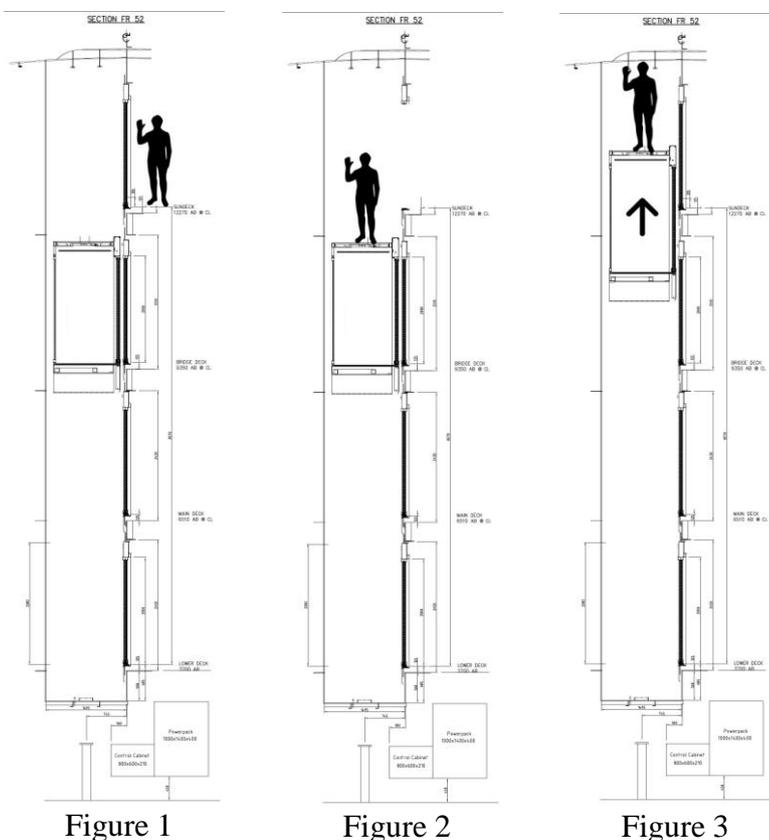
The Second Engineer called the lift car to the Bridge Deck and then entered the lift shaft onto the car top by manually opening the door on the Sun Deck and stepping onto the car top. When the lift doors on the Sun Deck closed, the lift rose to the Sun Deck position crushing the Second Engineer between the car top and the top of the lift shaft. The Second Engineer sustained severe injuries to his legs and ankles and is expected to be off work for at least three months.

Figure 1: The Second Engineer calls the lift to the Bridge Deck in preparation for entry into the lift shaft.

Figure 2: The Second Engineer opens the doors on the Sun Deck and enters the lift shaft by stepping on the car top.

Figure 3: When the lift doors on the Sun Deck close, the lift rises to the Sun Deck level trapping the Second Engineer between the car top and the top of the lift shaft.

- Working in the shafts and pits of passenger lifts is potentially dangerous and accidents in the past have resulted in many serious injuries and fatalities.

- An initial risk assessment should be made to identify hazards associated with work on each lift installation, including work requiring access to the lift shaft and pit.

- Safe working procedures should be drawn up for each lift installation. Persons who are authorised to carry out work on the lift installation must comply with these procedures.

- A permit to work system should be adopted when it is necessary for personnel to enter a lift shaft / pit or to override the control systems for any reason.

- Any work carried out must only be performed by authorised persons familiar with the work and the appropriate safe working procedures.
- Appropriate safety signs must be prominently displayed in the area and also on control equipment such as call buttons. Barriers should be in place if shaft doors are to remain open.

- Before attempting to gain access to the shaft / pit of any lift installation, the mains switch should be locked in the OFF position whenever possible.
