## **URGENT SAFETY RECOMMENDATIONS**

### **FLYER TO THE YACHTING INDUSTRY (01/2026)**

#### **Fatal Accident During Tender Launching Operations**

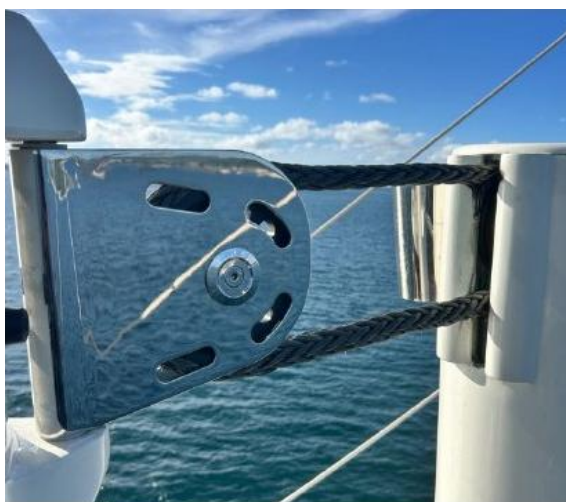
Fig.1 Topping lift sheave block

Without warning, the mast-mounted topping lift sheave block supporting the crane boom failed, allowing the boom and the suspended tender to fall suddenly. The boom struck the crew member, causing fatal injuries.

The investigation found that the retaining axle pin securing the sheave bearing sleeve had loosened and detached, allowing lateral movement of the sheave between the cheek plates and ultimately may have allowed the sheave to be pulled out under load. The subsequent side-loading caused wear within the sheave assembly that would likely have been difficult to detect without disassembly. The sheave block design did not incorporate a bridging plate to prevent distortion of the cheek plates.

- That sheave blocks are correctly marked with their Safe Working Load and that all such blocks are correctly rated
- Sheave blocks should be provided with adequate mechanical fastenings (such as an axle pin with a nyloc nut), and wherever possible, not rely on thread locking compound to mitigate the risk of working loose
- Where thread locking compounds are used, these should be appropriate for the intended application, considering in-service conditions and accessibility for inspection, and applied in accordance with the manufacturer's instructions
- Consideration shall be given to the incorporation of bridging plates or equivalent reinforcement to prevent distortion of the cheek plates (see fig.3)
