**Report of the investigation into
the accident on board the private pleasure yacht**

KIBO

**while at anchor in Majorca on 03 May 2015
resulting in a crew member suffering serious injuries**

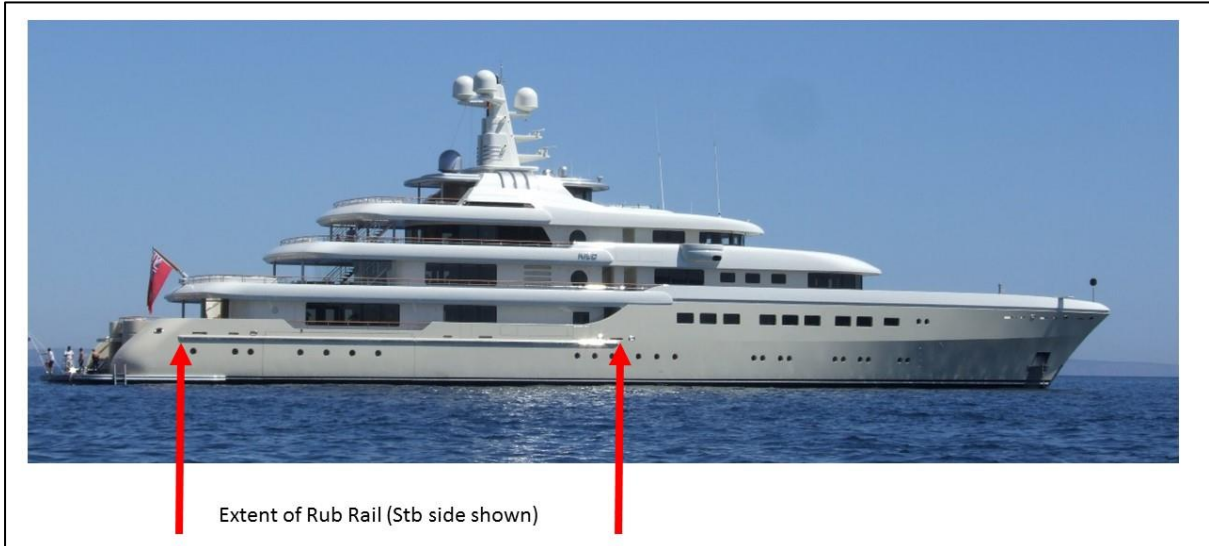
Figure 1

intention was to clean the rub rails on both sides of the hull, commencing with the rub rail on the port side.

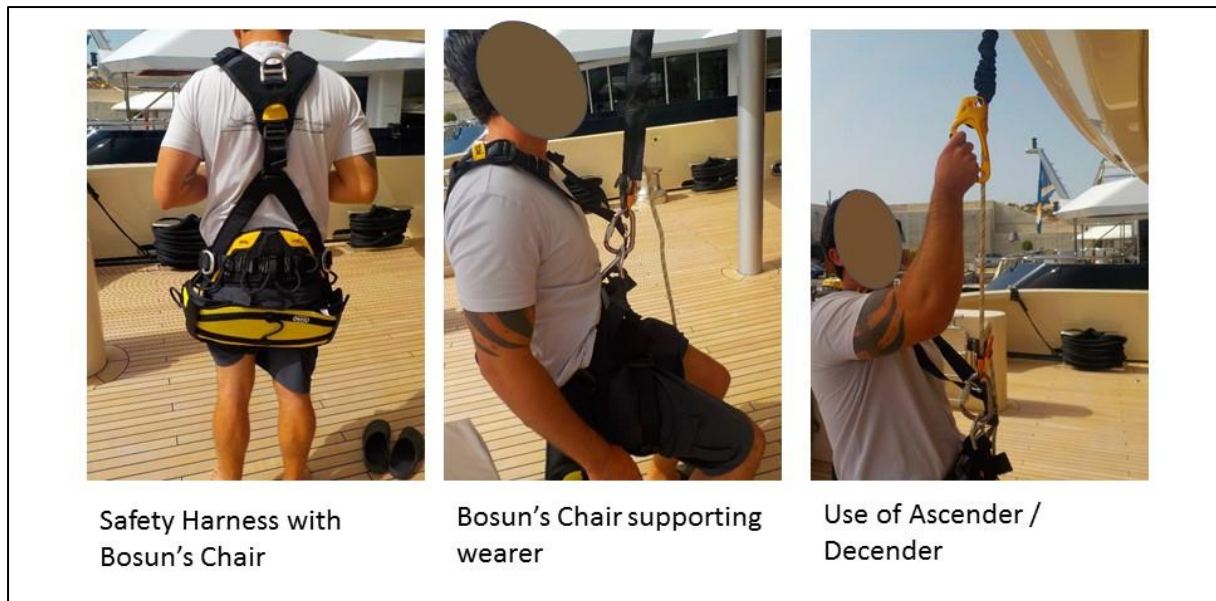
Figure 2

At 1002h, the Deckhand made his way to the portside main deck and donned the safety harness in preparation for commencing the work. He was joined by the 3/O who checked the fitting of the safety harness and attached the bosun’s chair. The safety harness was to be attached to a fender hook on the port side bulwark by a rope fitted with an “Ascender / Descender” device for controlling the working position of the wearer (see figure 2).

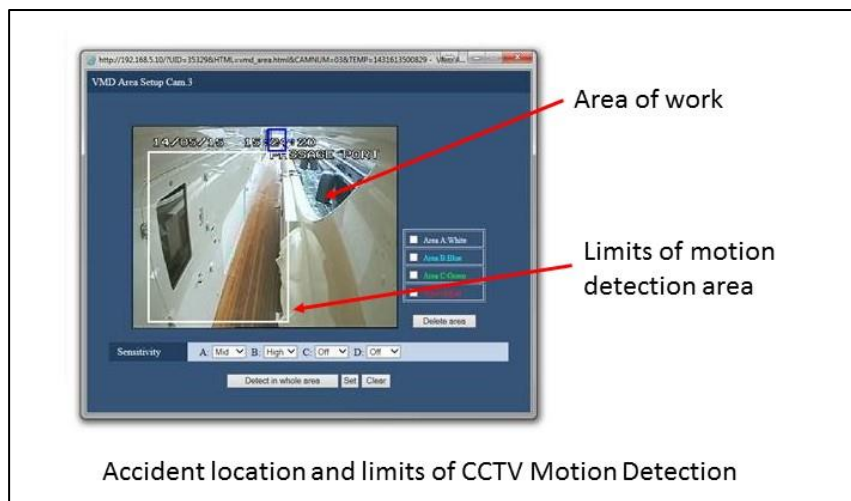
Figure 3

working over the side of the yacht and outside of the motion detection zone (see figure 3).

The Deckhand was last recorded by CCTV at 10:51:04h where he is visible working over the side of the yacht (but outside of the CCTV motion detection zone). There then follows a gap in the recording of 6 minutes 25 seconds before recording resumes at 10:57:29h. Recording resumes when the C/O enters the motion detection zone, immediately after the Deckhand has fallen from the worksite.

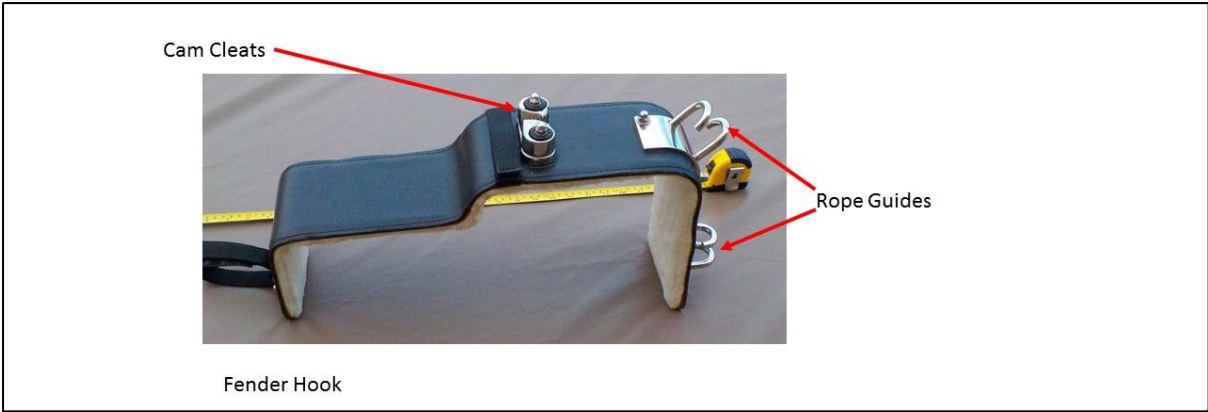
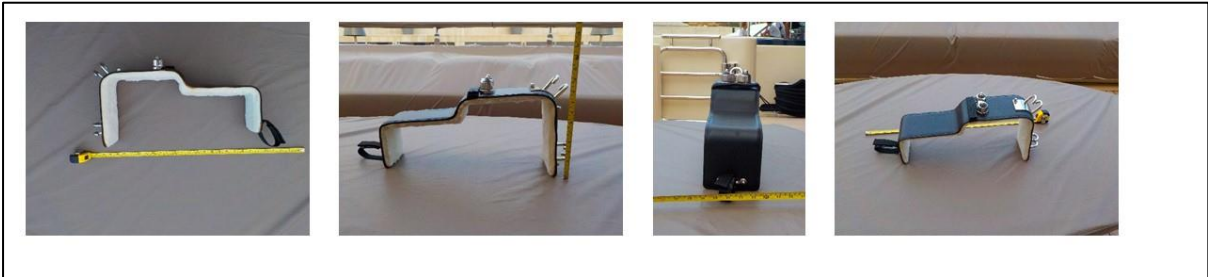
A fender hook is a device used to hang inflatable fenders from the bulwarks of a yacht. The fender hook sits over the top of the bulwarks and a rope attached to the fender is led through guides on the hook and secured by a double cam cleat. The fender hook consisted of a steel bracket with an upper leather covering and a lower lining of lambswool. Compression of the lambswool lining serves to secure the fender hook on the bulwark (while allowing lateral positioning along the length of the bulwark) and to prevent surface damage to the bulwark. The cam cleats and rope guides are attached to the outer surface of the fender hook. (See figures 4 and 5).

The mass of the fender hook was verified as 5.5kg.

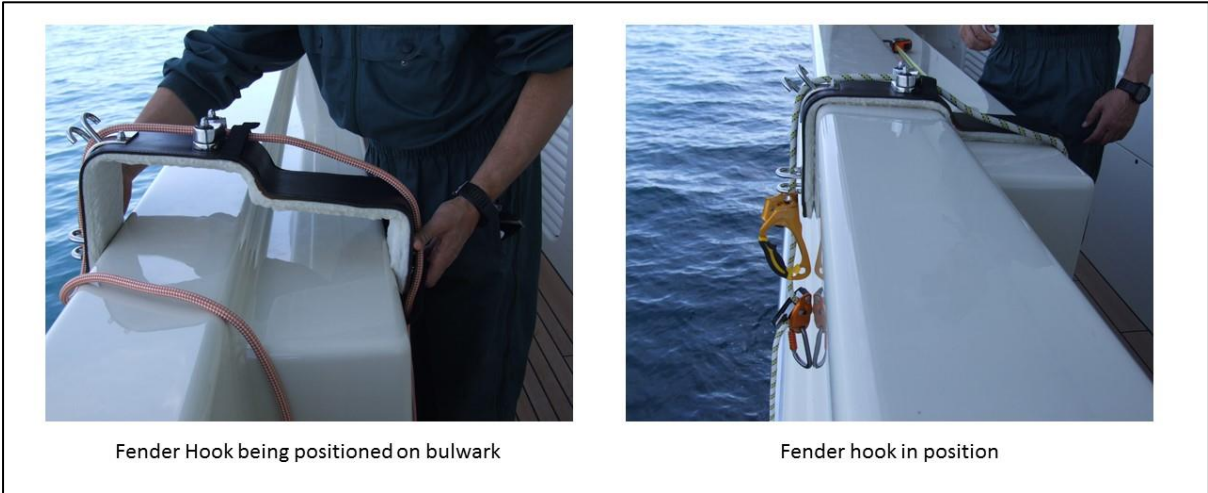
Figure 6

At the time of the accident, the Deckhand was only supported by the single line attached to the fender hook.

When properly seated on the bulwark the fender hook provides a stable platform from which substantial weight can be suspended. The only time when the fender hook was not properly seated was when it is being moved to a new position on the bulwark. The fender hook was recovered after the accident and examined by the Spanish authorities. Photographs of the fender hook, post accident, (see figure 6, above) show it free from distortion or other damage.

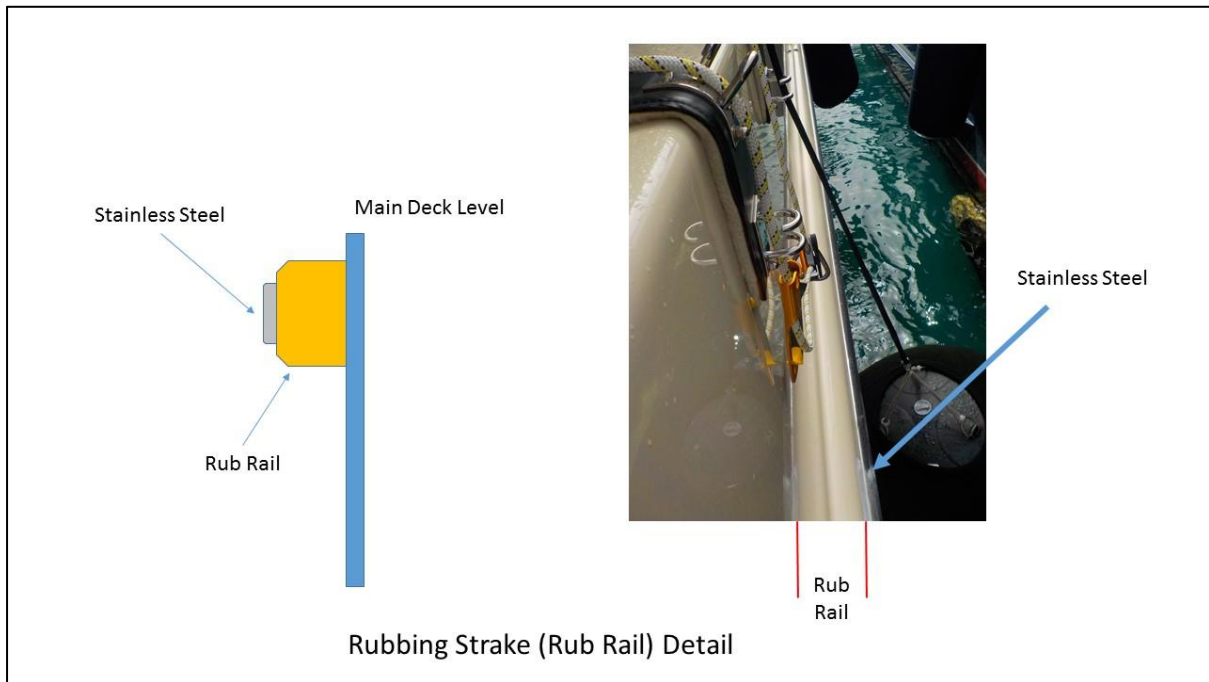
Figure 7

yachts and conventional ships). On KIBO the rub rails run along the aft part of the hull and are made of steel. An unpainted stainless steel rail is fitted to the outboard profile of the rub rail. This stainless steel rail serves little “protective” purpose and is fitted for mainly cosmetic reasons. The rub rails are fitted approximately 3m above the waterline.

Because the stainless steel parts of the rub rail are exposed to the elements they quickly tarnish and require cleaning with metal polish to retain their cosmetic appeal.

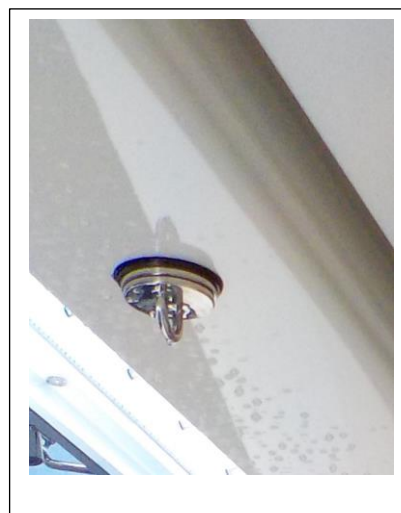
Figure 10

Typical padeye suitable for anchoring safety lines in the vicinity of the accident location

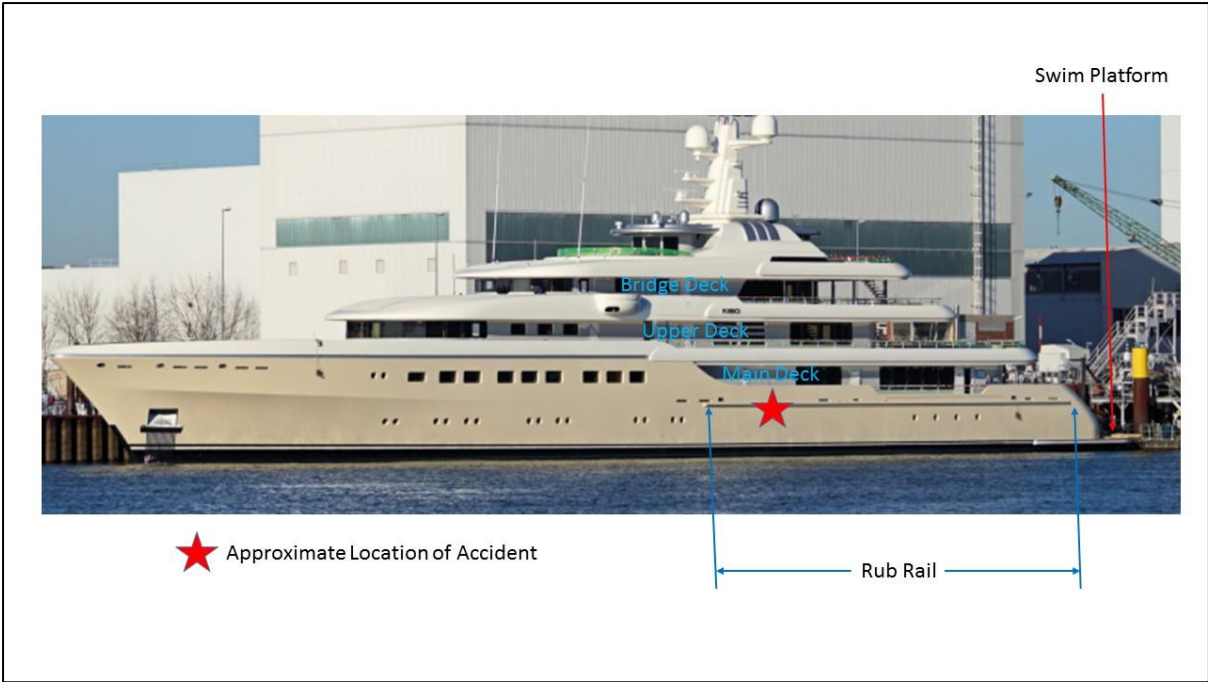
Overview of KIBO showing accident location

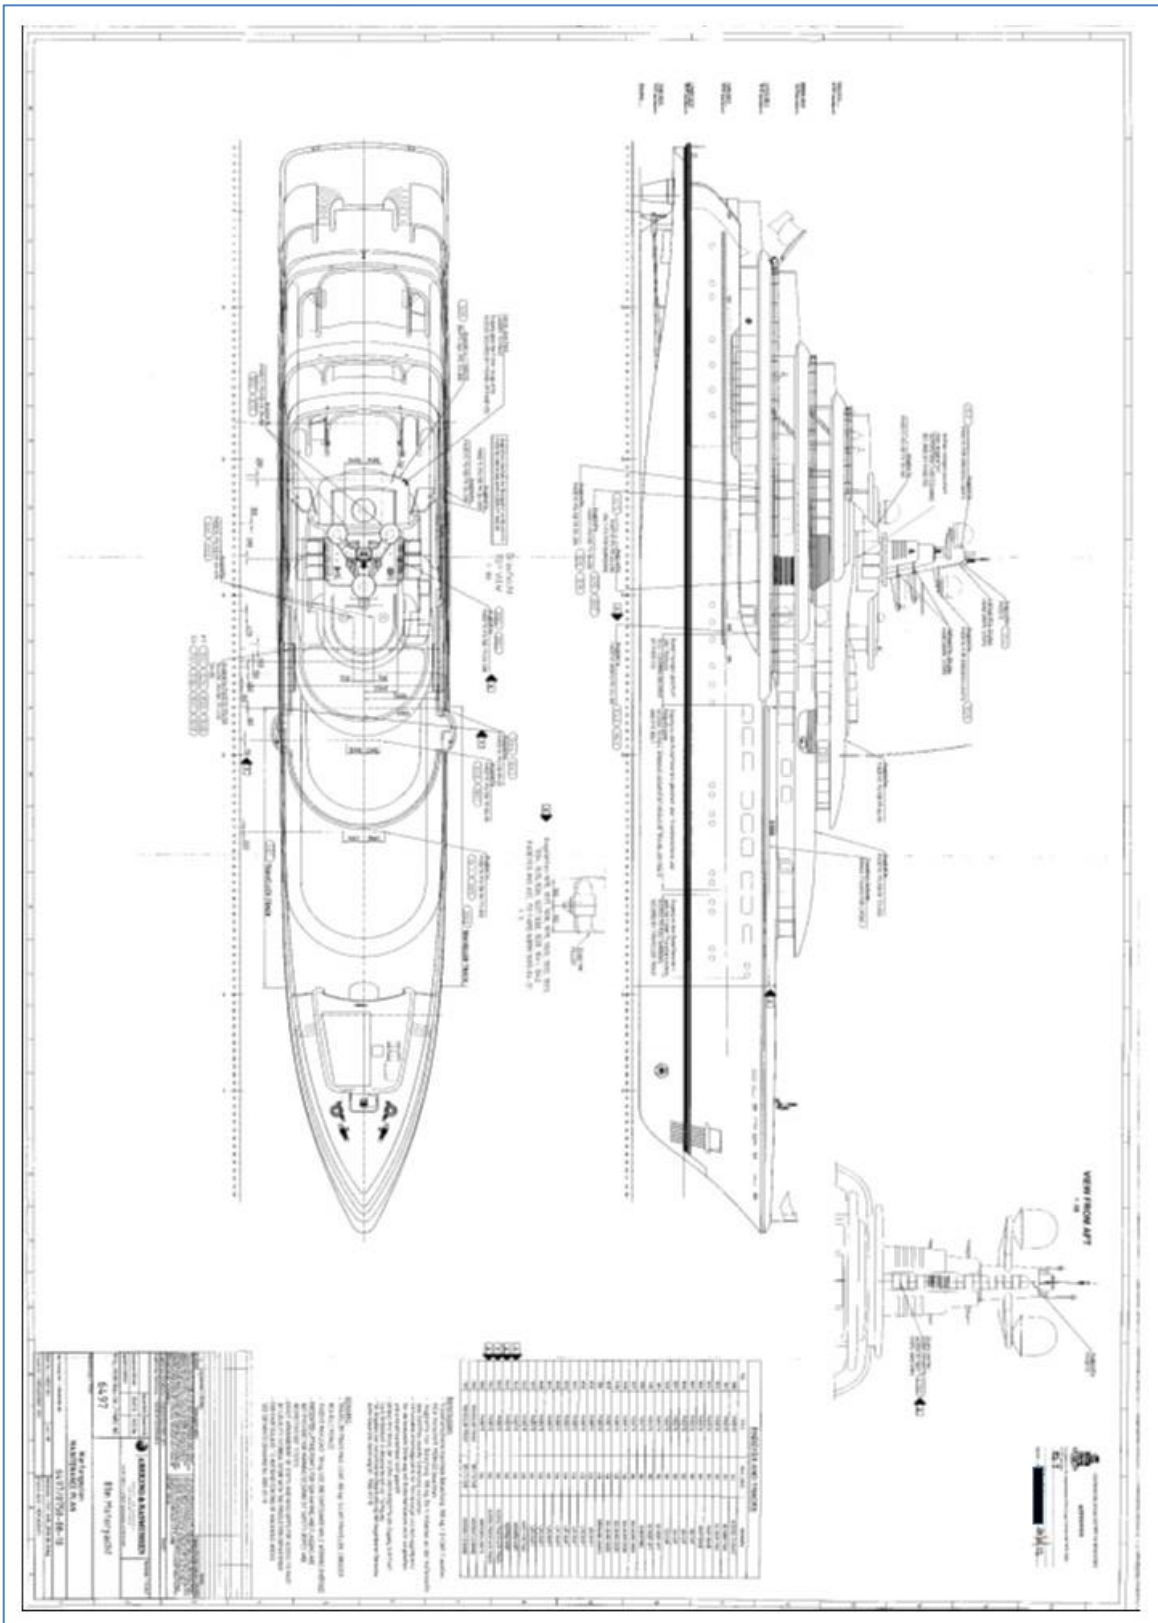
KIBO Maintenance Plan

These access arrangements are shown in construction drawing 6497/0750-08-10 (“Maintenance Plan”). This drawing was approved by the Cayman Islands Shipping
