# MARITIME AUTHORITY OF THE CAYMAN ISLANDS

## FLYER TO THE SHIPPING & YACHTING INDUSTRY

## Serious Failure During Tender Launching Operations

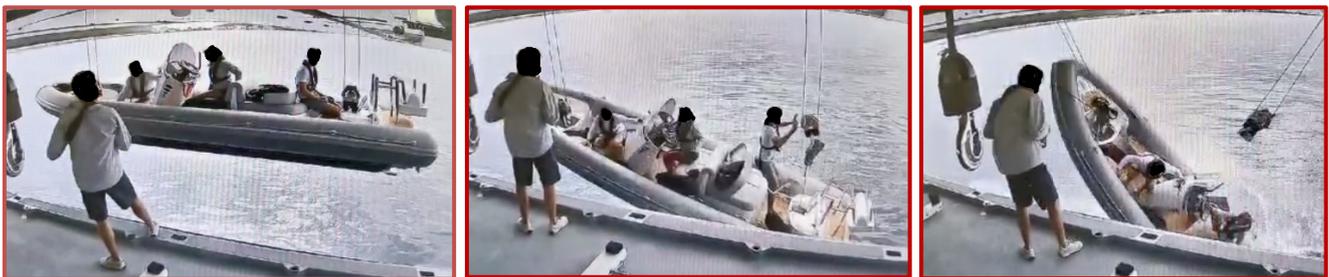
On 26 May 2019 a tender was being launched through a side shell opening of a large yacht at anchor. Three crewmembers were on board the tender during the launching operation. While the tender was being lowered, the aft attachment between the tender and the launching appliance failed catastrophically causing the rear of the boat to fall to the water.

Fortunately, none of the crewmembers on board the tender were seriously injured during the incident. However, serious injuries to the crewmembers could easily have occurred as a result of the fall to the water or by contact with the free-swinging hook and release gear.

- When inspecting and testing launching appliances it is important to consider the entire system under load. This will include the launching appliance and its foundations, the falls in use, hooks & release gear, the attachment to the craft being launched and the craft itself.
- “Man Riding” during the launching of any watercraft should only be undertaken when the entire system has been designed, tested and certified for such activities. Suitable standards for man riding

- The risks inherent in all lifting operations, including the launching of watercraft, must be rigorously assessed and safe working practices developed.
- When “man riding” during launching operations, the minimum number of persons necessary for safe launching should be present in the craft being launched.
- Appropriate personal protective equipment such as lifejackets, “bump hats”, etc should be employed whenever their use is indicated by the risk assessment.

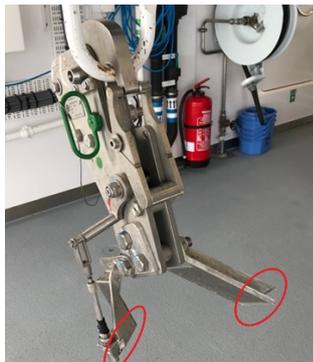
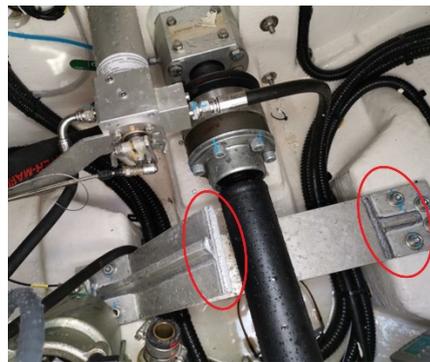
On examination it was found that the hook and release gear had remained intact during the incident. The welds connecting the tender itself to the release gear were found to have failed inside the tender.
