Report on the investigation of
the cargo tank explosion and fire
on board the chemical tanker

Stolt Groenland

Ulsan, Republic of Korea

REPORT NO 9/2021

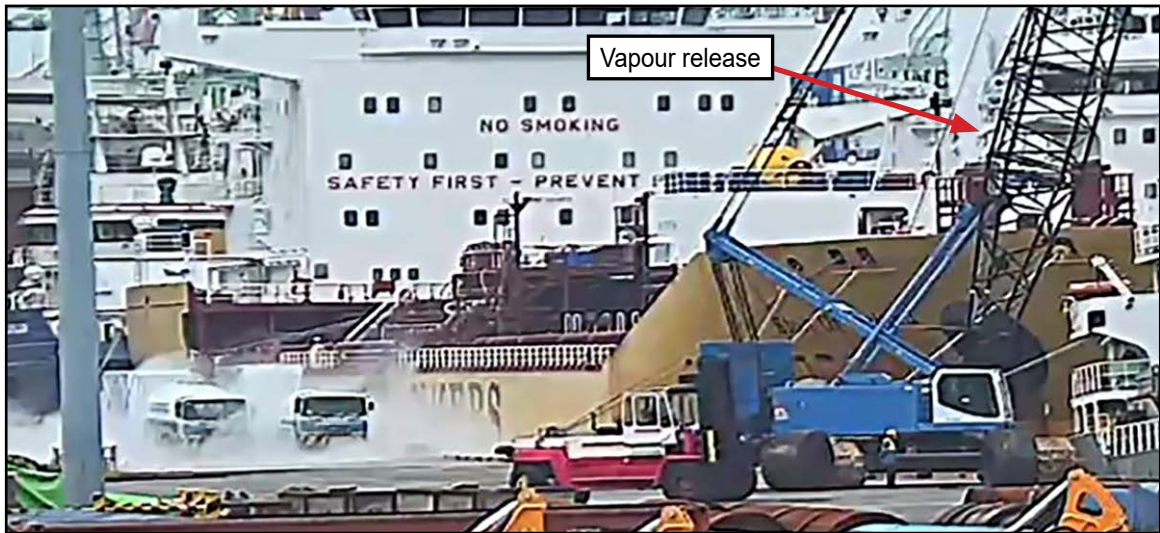
Figure 3: CCTV still showing vapour release from 9S p/v valve

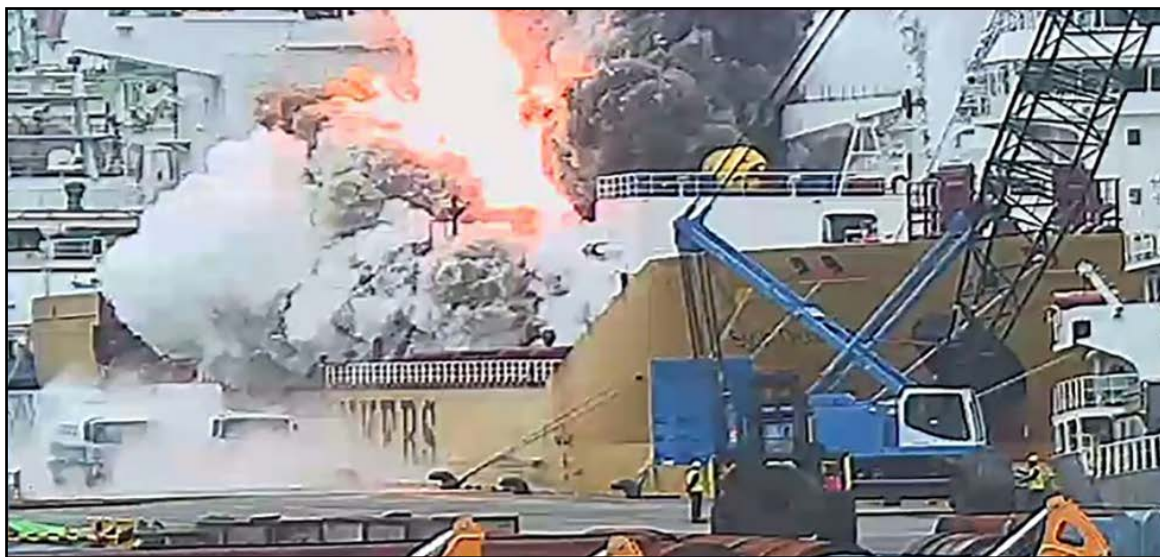
Figure 5: CCTV still showing vapour ignition

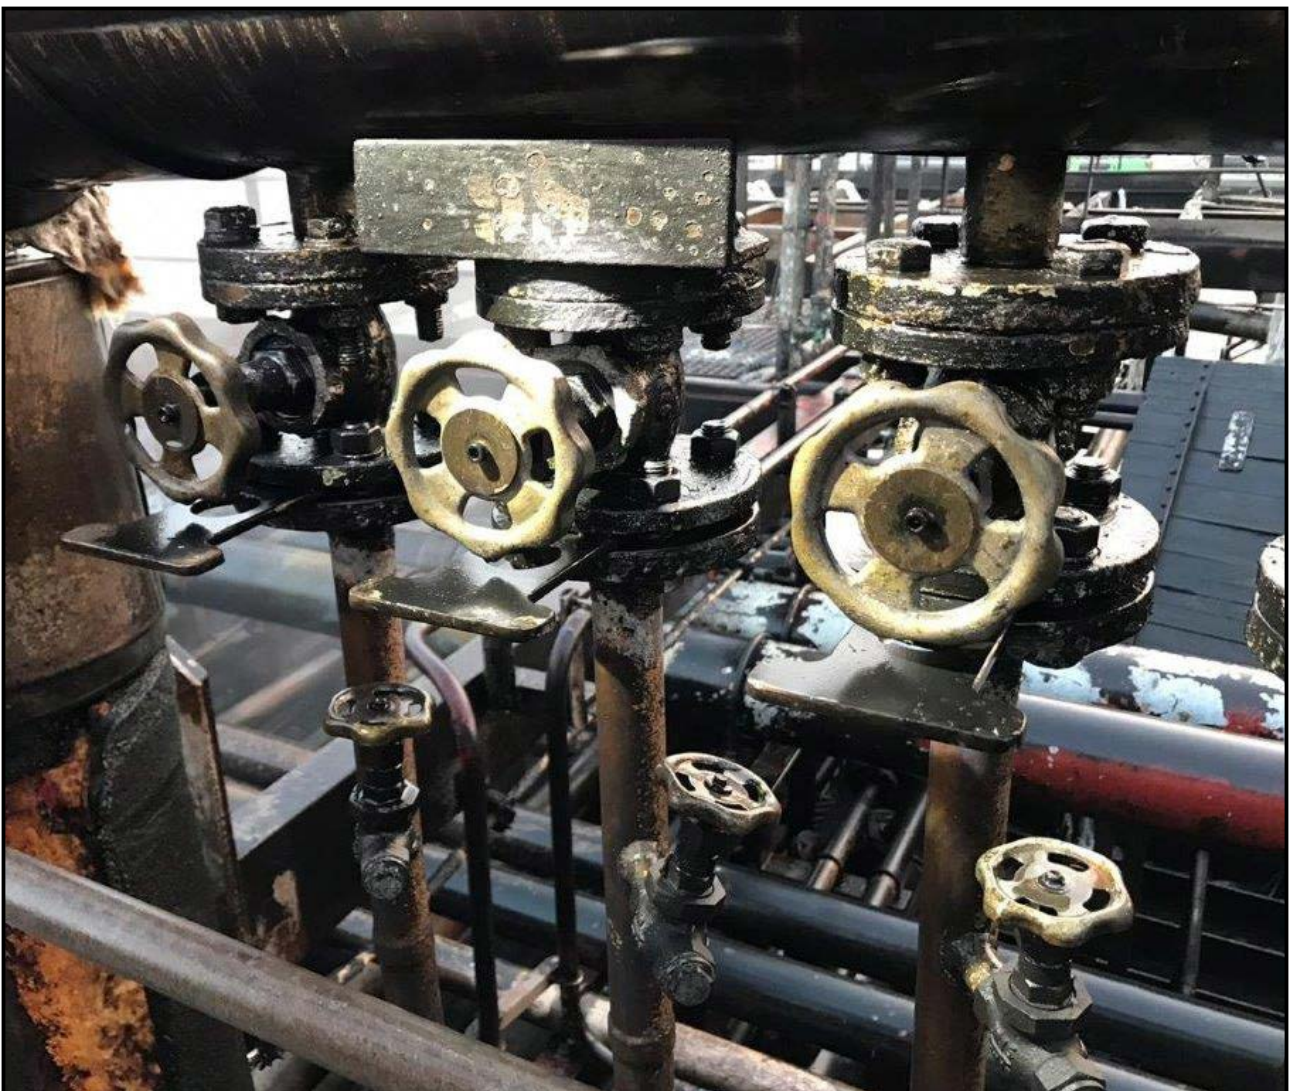
On 7 October, the analysis of samples of styrene monomer taken from *Stolt Groenland's* cargo tanks 6C and 6P indicated that the concentrations of the inhibitor 4-tert-Butylcatechol (TBC) were 8 parts per million (ppm) and 7ppm respectively. The following day, MAIB inspectors were allowed access to the vessel. However, the presence of hazardous chemicals and fire damage limited the inspection to the main deck primarily. A further inspection on 12 November was co-ordinated by the Korea Coast Guard and the KMST. These inspections, and inspections conducted by or on behalf of Stolt, confirmed that the heating coils in 9C and 9S were closed and blanked (**Figure 10**), and that vapours released from the p/v valves for 9S and 9C had ignited.

Figure 10: 9S heating control valves

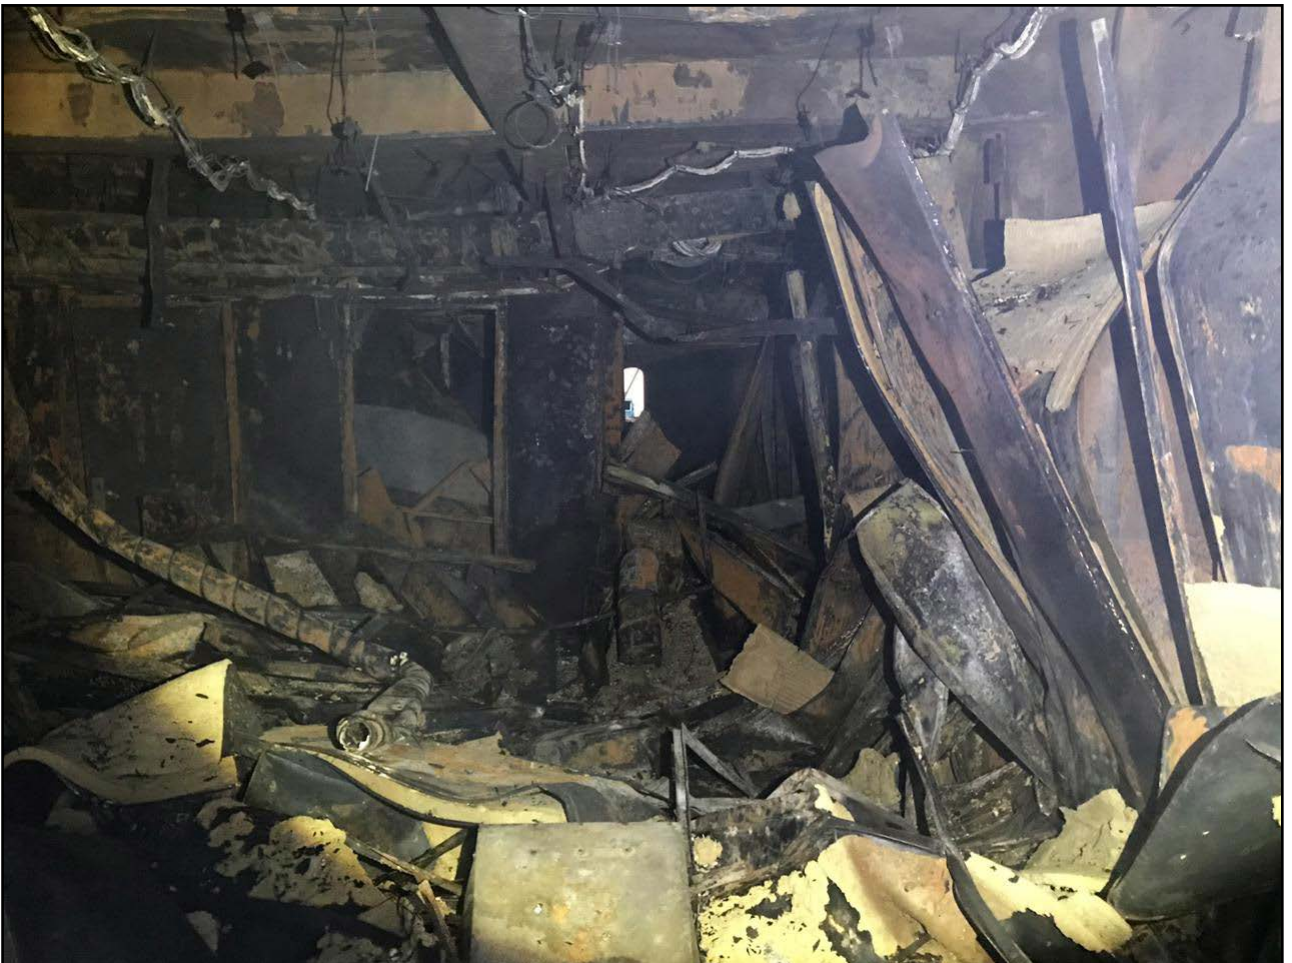
The tanker's accommodation block sustained extensive internal fire damage (**Figure 15**). The deck between the technical room and the CCR had collapsed, and both spaces were burned out. Heat and smoke had also penetrated the bridge and damaged much of its equipment. Other than broken windows, many of which were broken by firefighters during the emergency response, external damage to the front of the accommodation block was minimal (**Figure 16**).

Figure 15: Accommodation interior

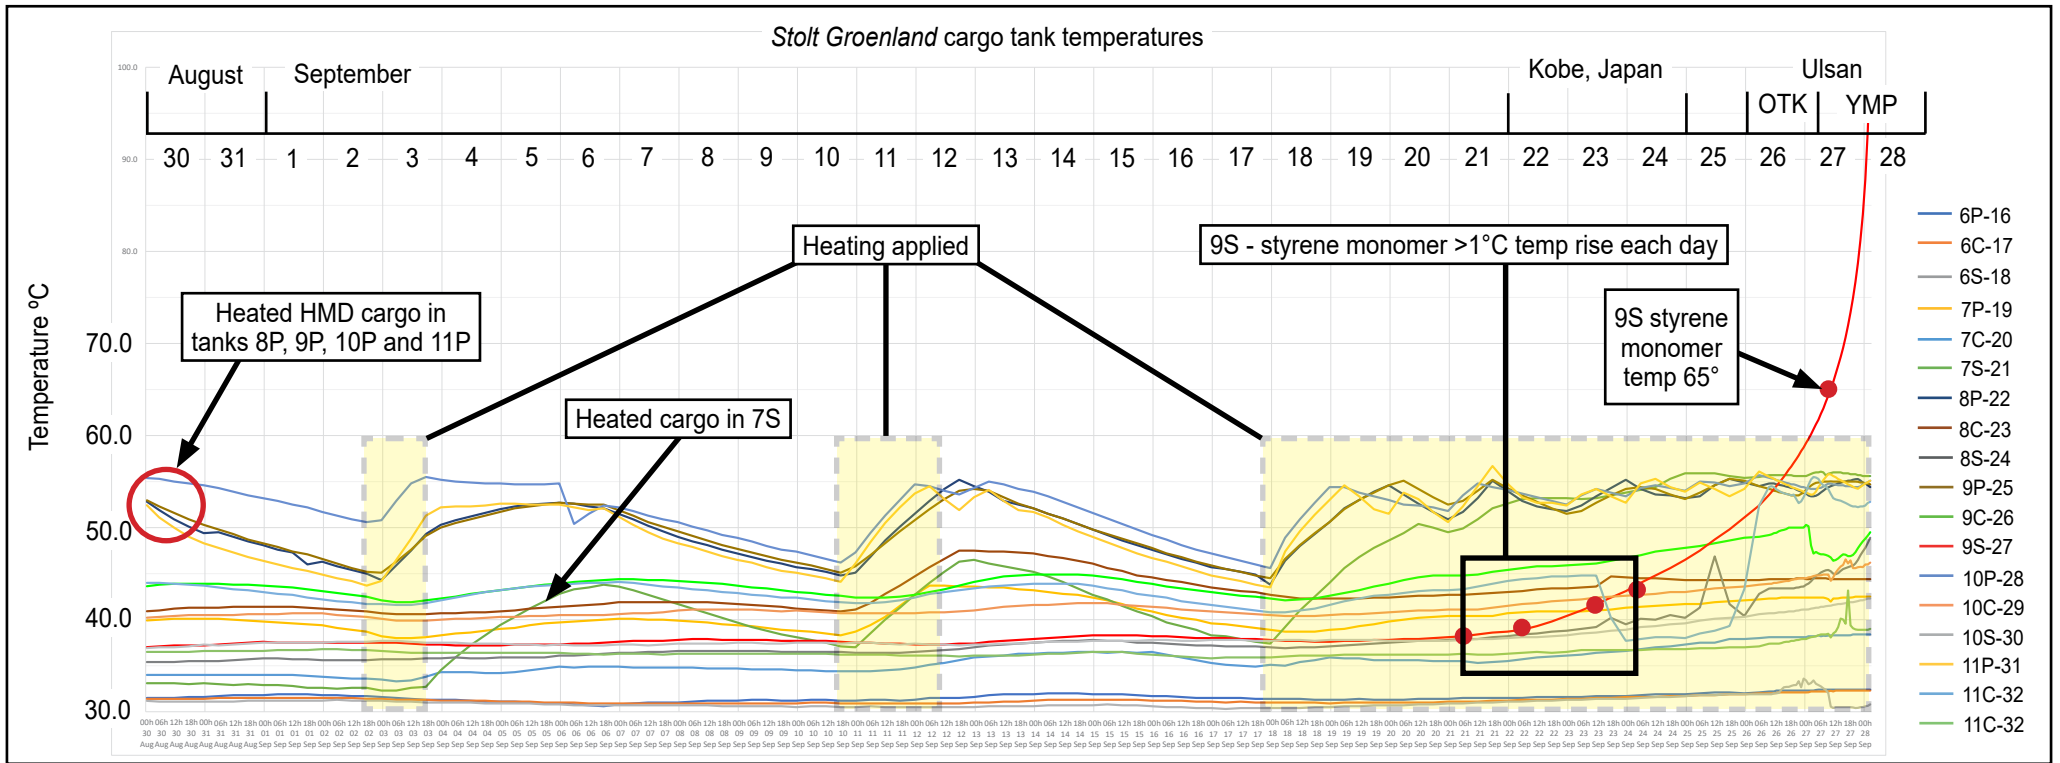
Figure 17: Cargo temperatures recorded on the VDR
