# Fatality on board the motor yacht *Calliope*

Rozelle Bay, New South Wales | 8 February 2013

**ATSB Transport Safety Report**  
Marine Occurrence Investigation  
297-MO-2013-003  
Final – 12 May 2014

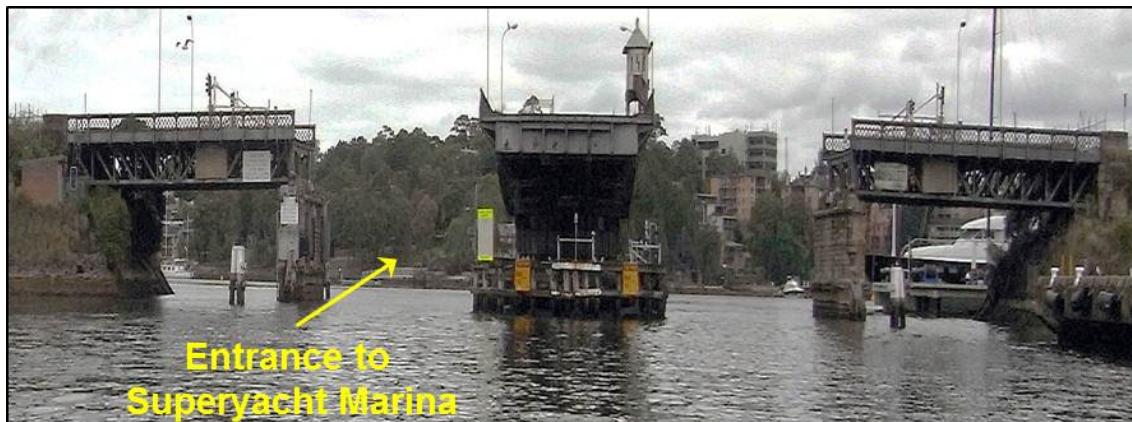
**Figure 3: Glebe Island Bridge opening**

*Calliope* passed through the opening of the disused Glebe Island Bridge at low tide (Figure 3) and by 1010 was safely berthed with its stern to the wharf (a Mediterranean moor) at the marina.

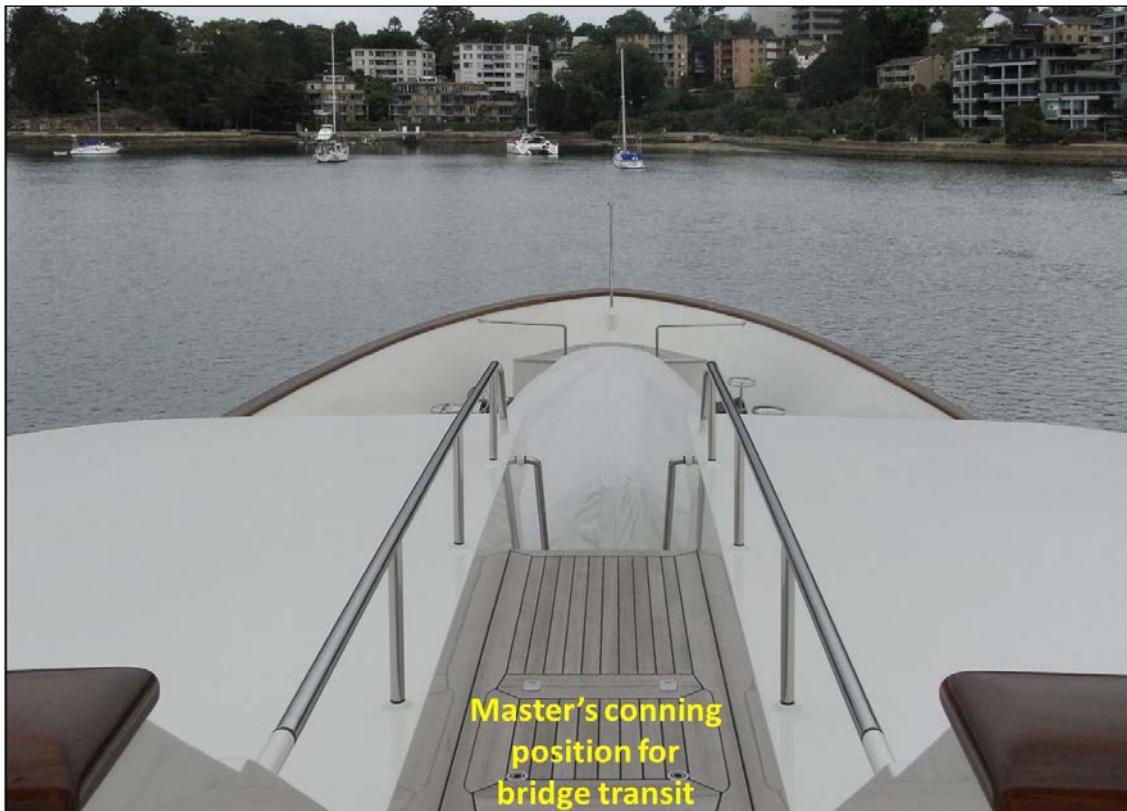
**Figure 4: Conning position**

At 1341, *Calliope* cleared the berth and the master moved to a central position in front of the navigational bridge (Figure 4).
