REPORT

SL 2019/01

REPORT ON AIR ACCIDENT IN PORT OF BERGEN, HORDALAND COUNTY, NORWAY, 10 MAY 2017 INVOLVING AIRBUS HELICOPTERS AS 350 B3, G-HKCN

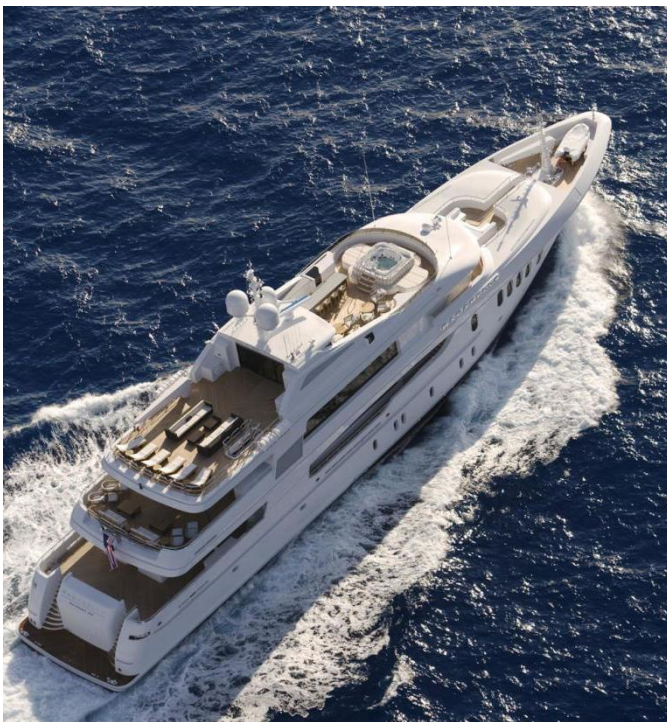
1.17.2.1 M/Y Bacarella is a 59.7 m long yacht, built in 2009 and registered on the Cayman Islands. It is owned by Sun Vessel Global Ltd.

Figure 9: M/Y Bacarella; the upper aft deck was used as a helideck. Source: YachtCharterfleet.com
