**Report of the investigation of
the accident resulting in one fatality and one serious injury
during the mooring of the motor yacht**

JEMASA

**in Phuket, Thailand
on 18 February 2009.**

Casualty 01/2009

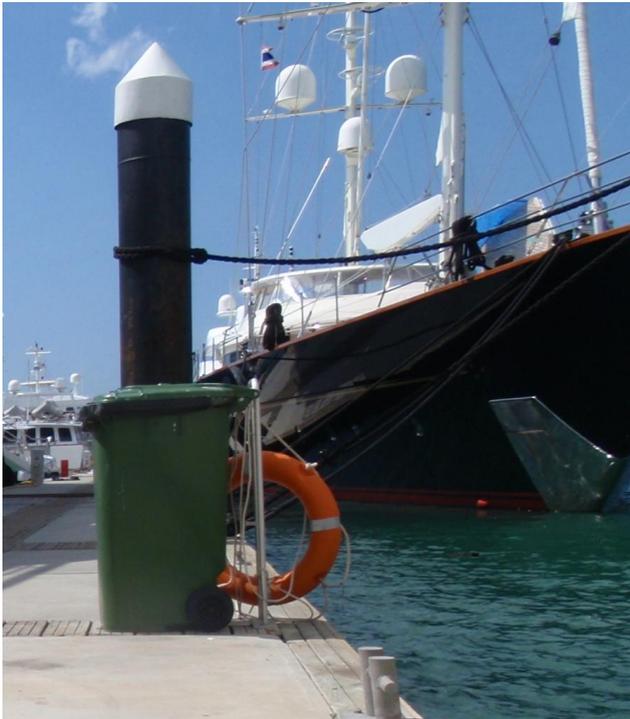
Figure 9: Steel Pile used for mooring.

3. Moored directly to the steel piles that anchor the floating quay.

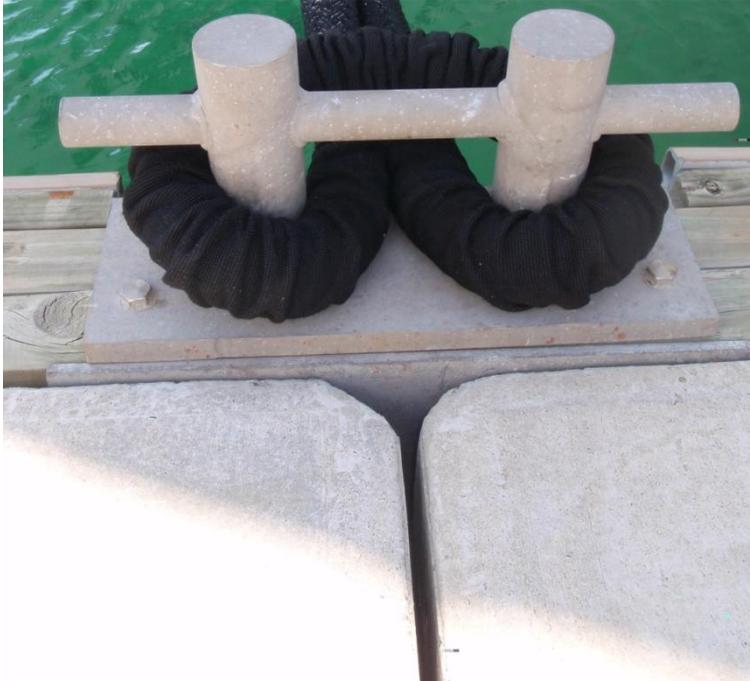
Figure 13: Bollard mounted through two concrete pontoons

stations. This bollard was held in place by a single rod running through the pontoon block and a bolt connected to a backing plate behind the soft wood wales.

When the load on this bollard was increased and the soft wood wales failed, it placed a torque reaction centred on the single through pontoon rod. In turn, this rod failed and the bollard was freed from the quay.

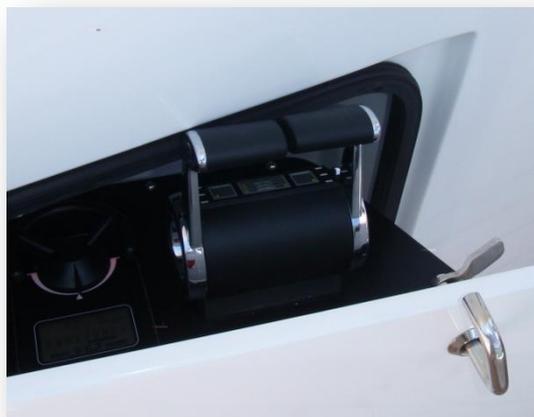
After the yacht had completed mooring, with four lines ashore, a crew member placed the bridge wing controls in the "full ahead" position and closed the control station. When the control station was closed, the yachts engines were running with control still at the port bridge wing station.

The engines engaged, the yacht proceeded to move ahead and the yacht broke free of its moorings. No mooring ropes parted but three of the mooring points in use on the quay failed. When the moorings failed, two bystanders on the quay were struck by flying debris and / or recoiling mooring ropes. One person was hit on the legs which were fractured. The other person was struck on the head and sustained serious injuries.
