Report on the investigation of
a fall from height on the bulk carrier

Equinox Seas

resulting in one fatality

REPORT NO 12/2024

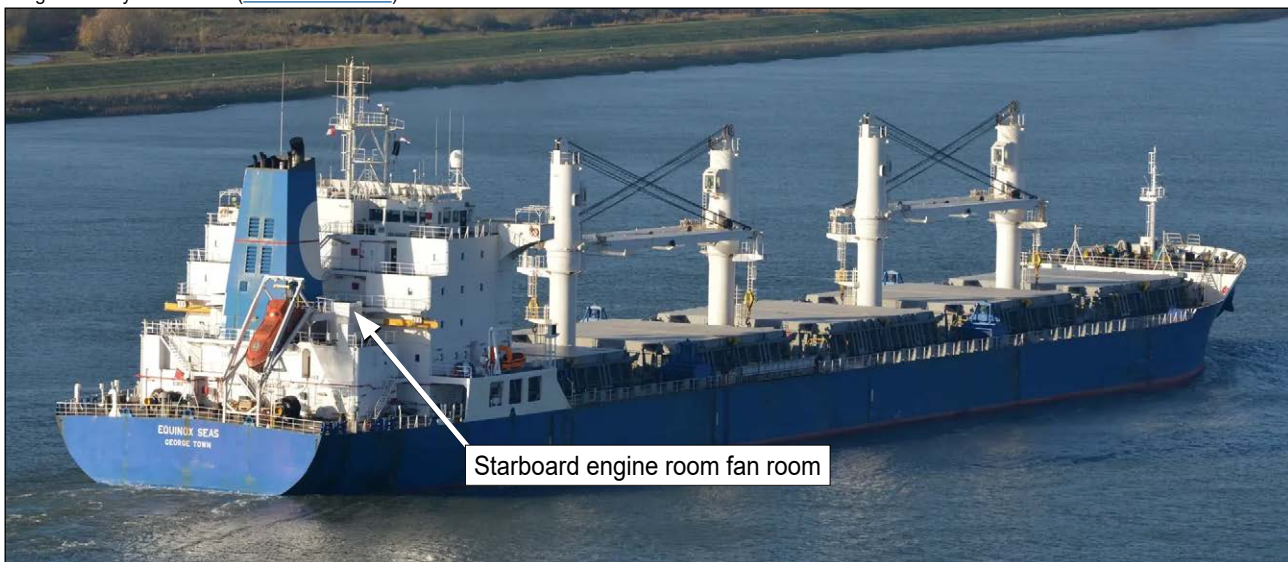
Figure 2: *Equinox Seas* general arrangement

Equinox Seas had two engine room ventilation fans situated in separate fan rooms either side of the funnel casing on the second deck (**Figure 2**). Each fan was installed within a cowling that was fastened to a pedestal with an internal diameter of 1.20m and a height of 0.79m above the deck level. Within each pedestal was a fire damper that enabled the ventilation trunk to be closed off in the event of a fire.

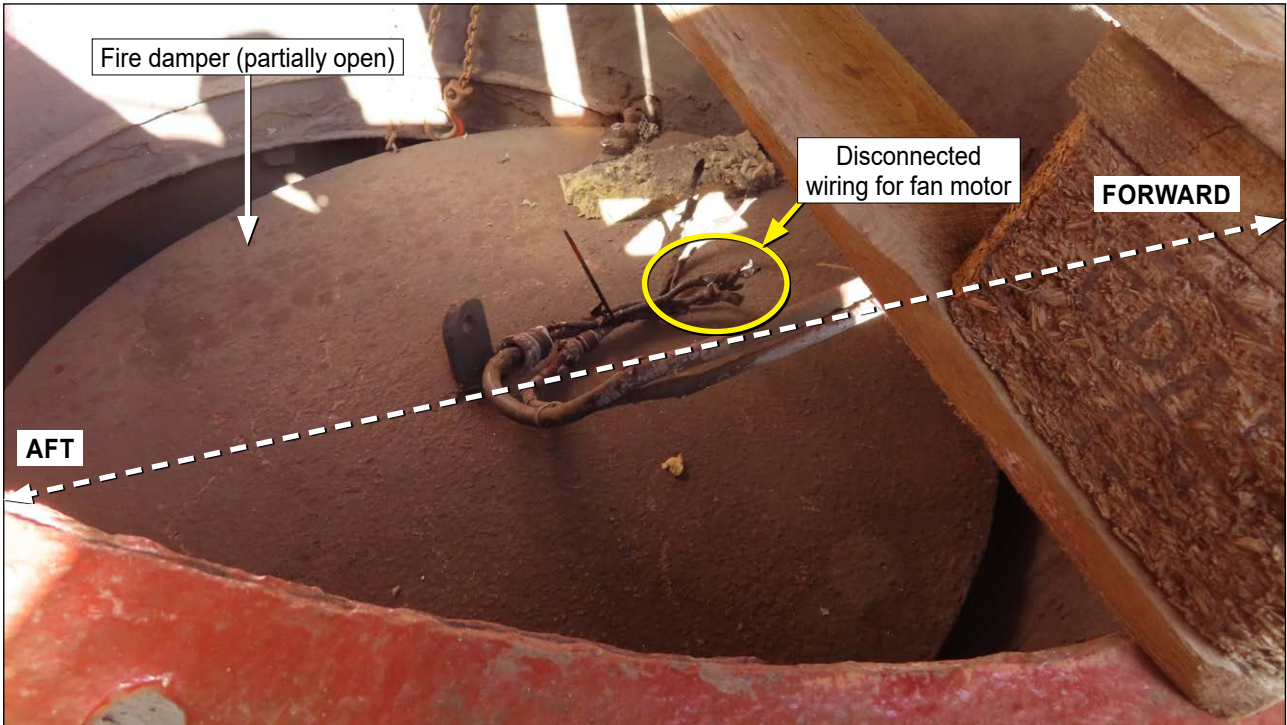
Figure 4: Starboard engine room fan pedestal fire damper

The starboard ventilation trunk fire damper comprised a steel disk pivoted along its central axis, offset by 45° to the centreline of the ship. The damper was designed to rotate by 90° between the open and closed positions. In the closed position, across the airflow, the damper rested against seats set into the pedestal. The aft inboard half of the flap rotated downwards to open the damper (**Figure 4**). An actuator was installed to allow the damper to be operated remotely.

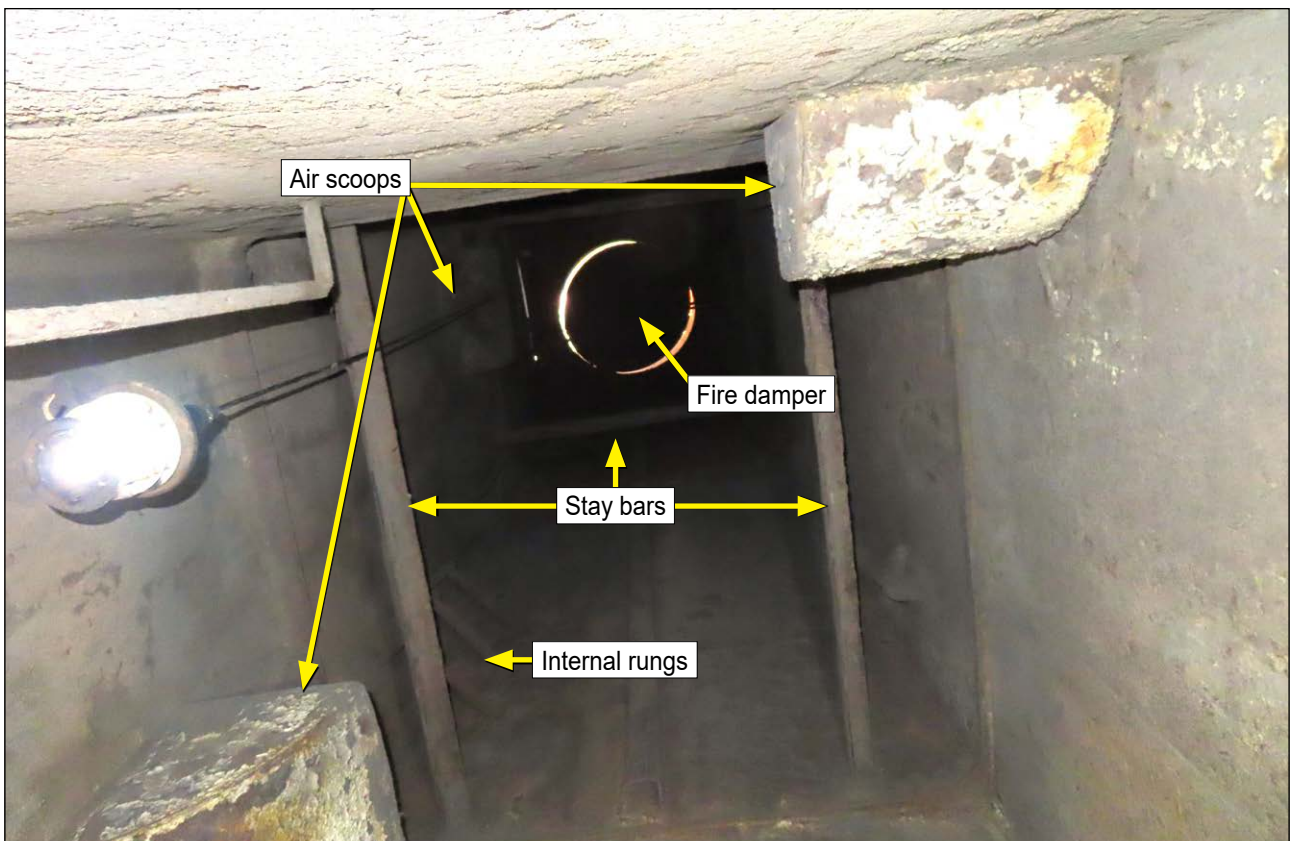
Figure 5: Starboard ventilation trunk internal structure, looking up from the access cover

At the base of the ventilation trunk at deckhead level on the second platform deck, a plenum chamber contained three distribution duct outlets that supplied ventilation to the engine room. Ventilation to the engine casing at main deck level and the first platform deck was provided by a series of scoops set into the vertical trunk leading to distribution ducts on those levels. The trunk was fitted with four stay bars of 50mm angle profile, two each at deck one and main deck levels. Internal rungs providing means to ascend the trunk for maintenance were installed up the forward outboard corner (Figure 5).
