**Report of the investigation into
the accident on board the private pleasure yacht**

KIBO

**while at anchor in Majorca on 03 May 2015
resulting in a crew member suffering serious injuries**

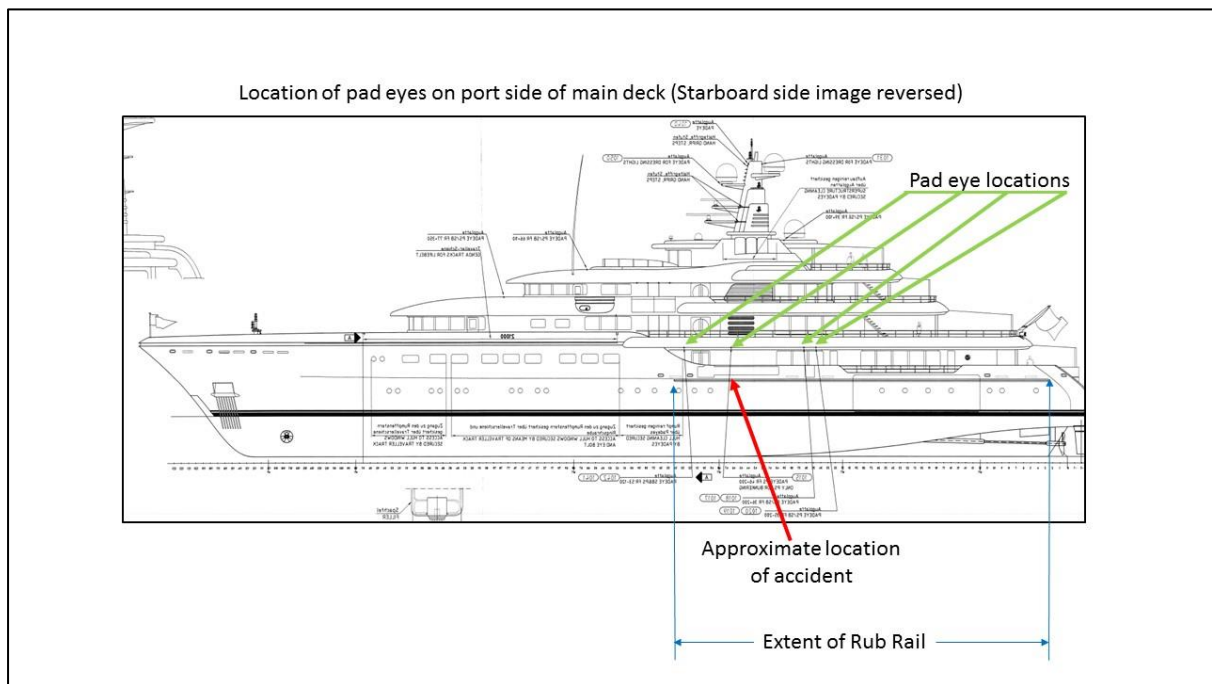
Figure 8

These access arrangements are shown in construction drawing 6497/0750-08-10 (“Maintenance Plan”). This drawing was approved by the Cayman Islands Shipping

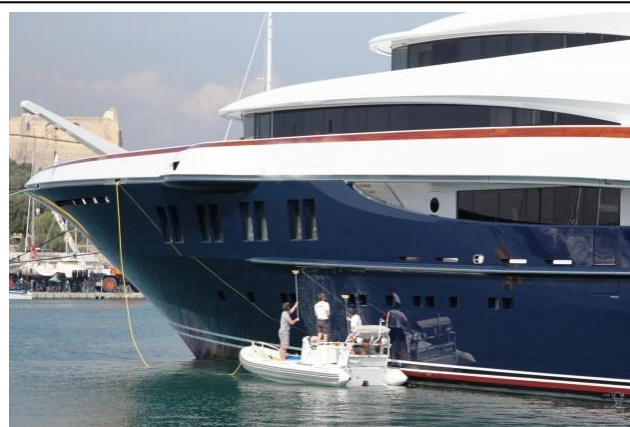
Typical yacht hull washing
(image c/o www.liveyachting.com)

This arrangement was not suitable for polishing the stainless steel parts of the rub rails fitted to KIBO because the polishing required close proximity with the work surface and detailed application of metal polish.

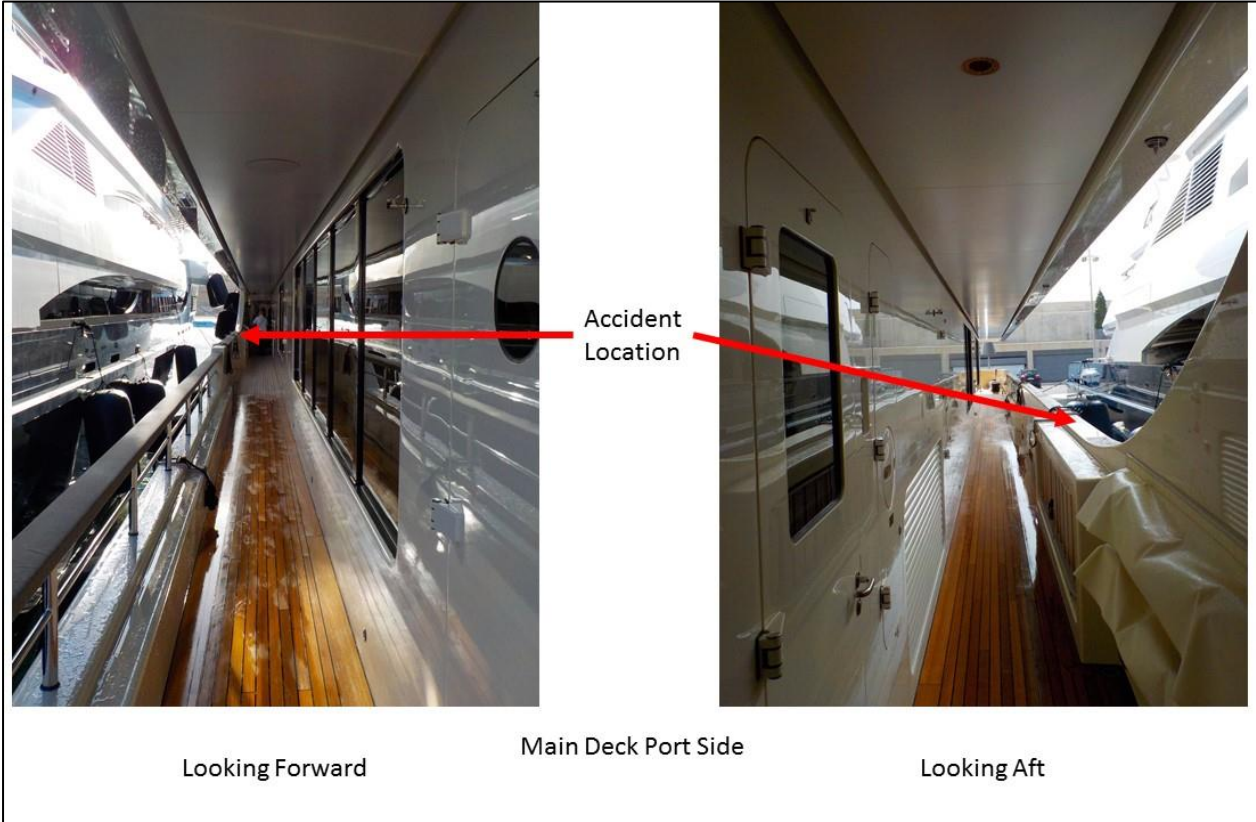
Main Deck Port Side

Overview of KIBO showing accident location
