CAYMAN ISLANDS SHIPPING REGISTRY

FLYER TO THE LARGE YACHT INDUSTRY

“Near Miss” Involving Watertight Door Closure.

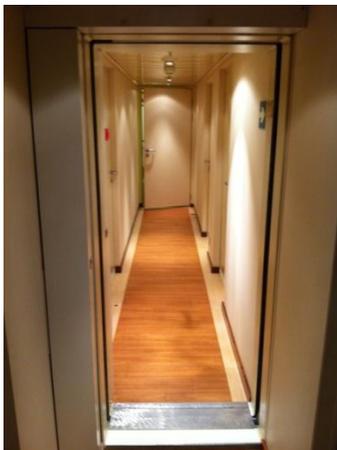
Door Open

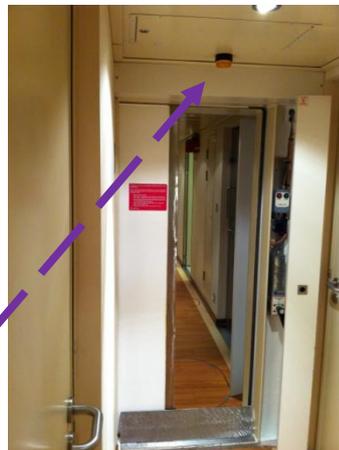
Door Closing

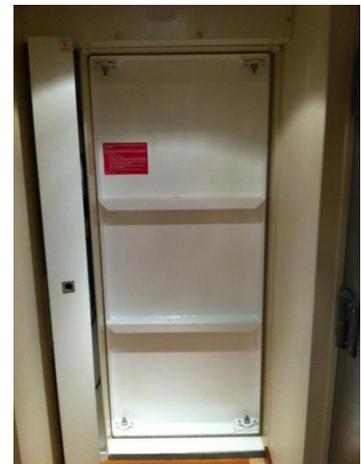
Door Closed

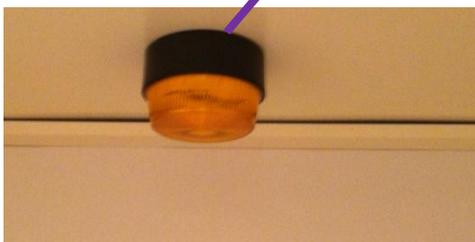
Visual Alarm (Door Closing)

- Under no circumstances should any person attempt to pass through a water tight door that is in motion (closing **or** opening), or when the local alarm is activated. **“If it moves – you don’t.”**
